STRATFORD TOWN HALL

LISTED BUILDING CONSENT APPLICATION  
FOR CONSERVATION OF SHAKESPEARE STATUE

HERITAGE STATEMENT

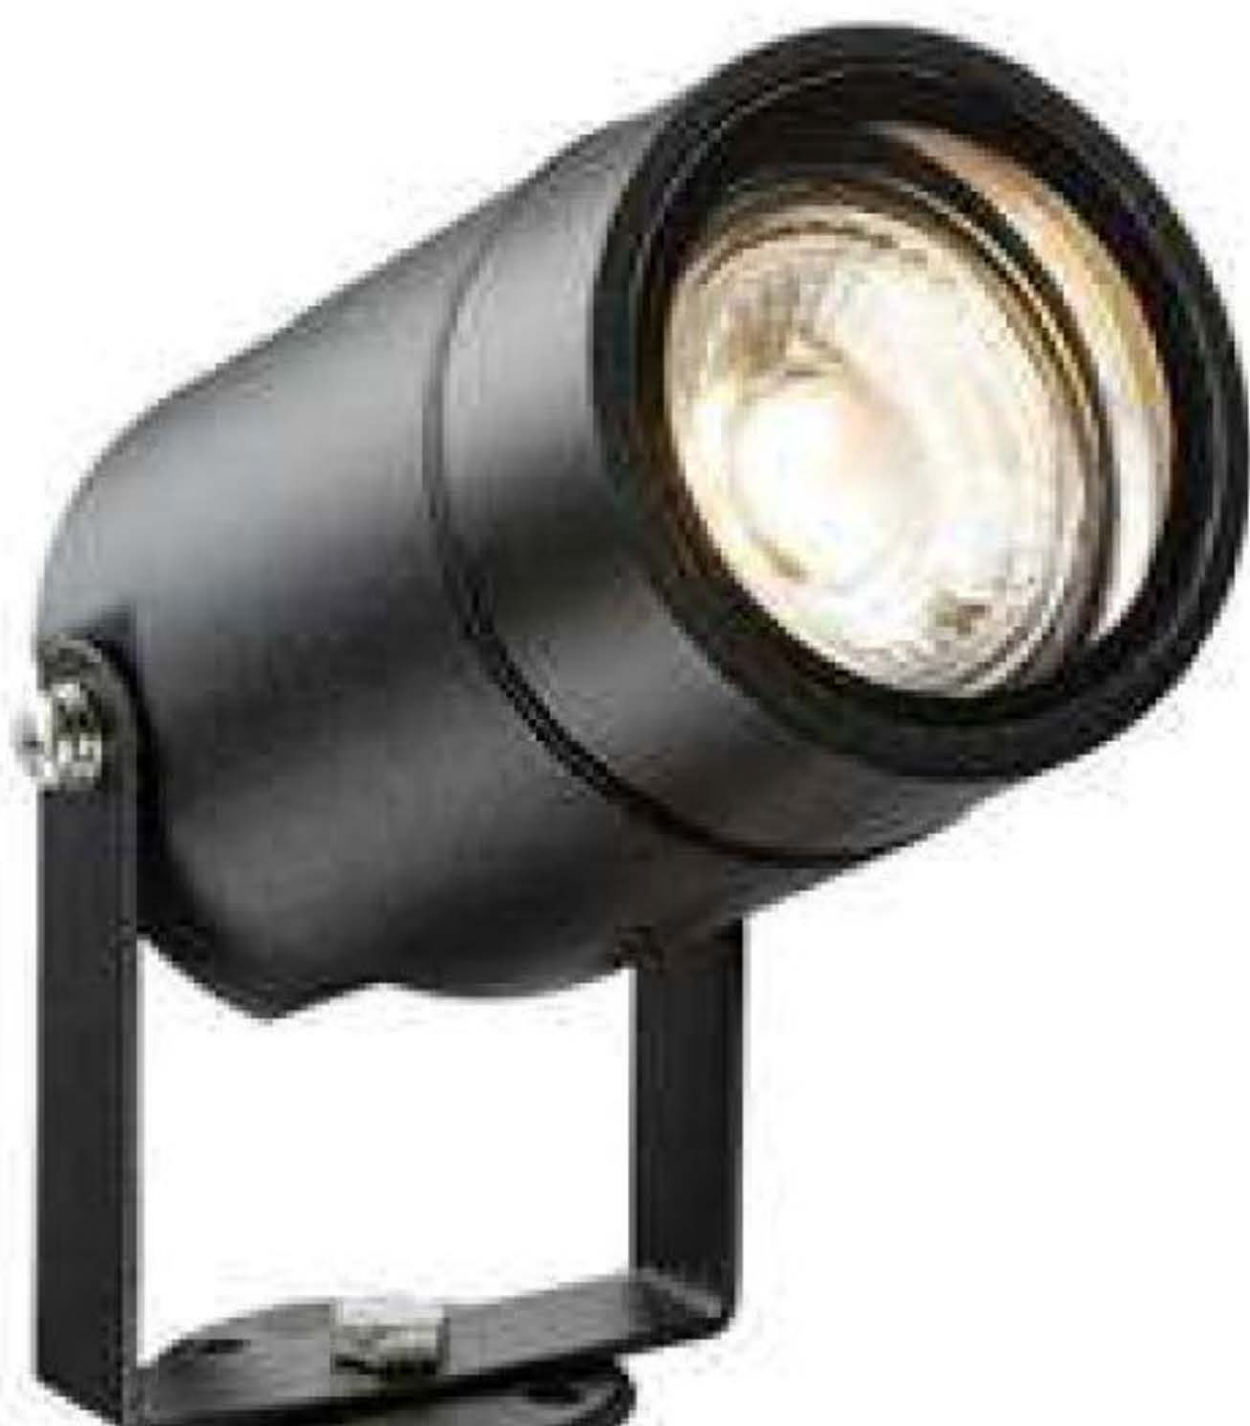
- 3.4 **Lighting:** The existing lighting to the statue comprised a pair of light fittings on metal stalks. They were large fittings and out-of-date. It is proposed to replace this arrangement with a pair of new metal stalks, each with a pair of smaller 60mm diameter LED fittings. Steane Electrical have suggested the new installation. The additional fittings will provide a more even illumination in a warm-white tone.

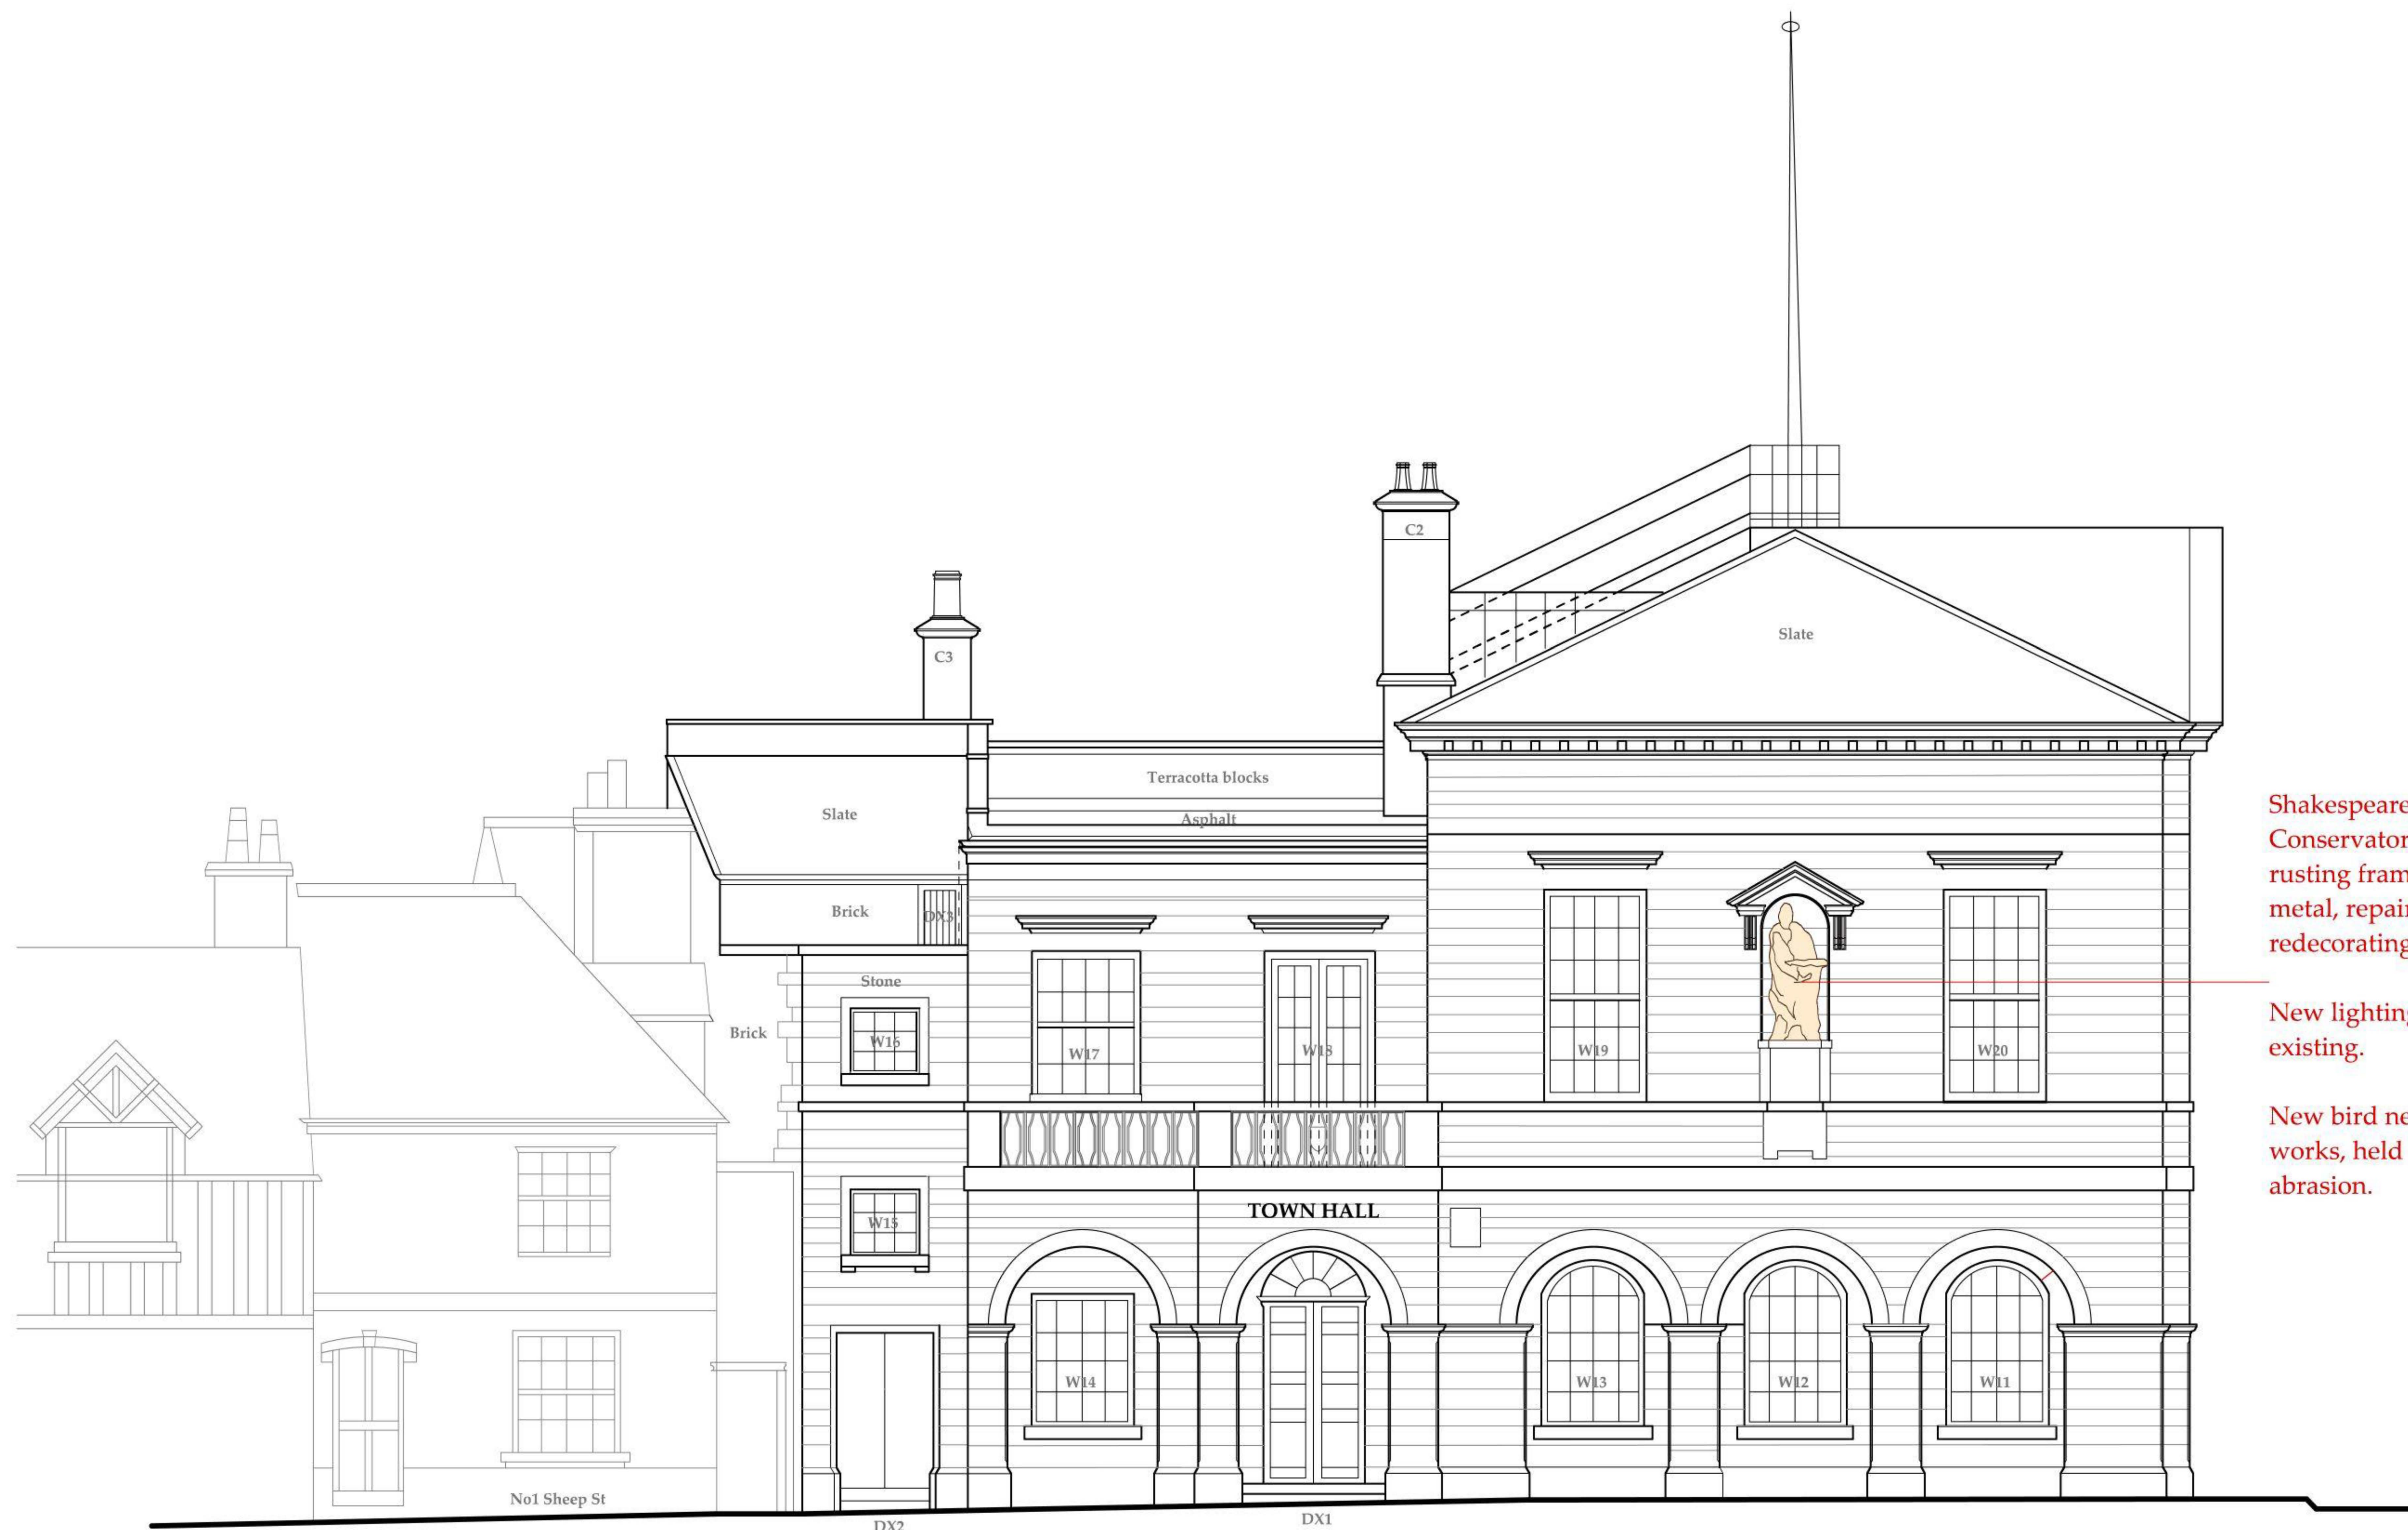
Project	Stratford Upon Avon Town Hall	Scale	1:100 @ A3	Job No.	1959
Drawing	East (Sheep St) Elevation Showing Repairs	Date	May 2020	Drg. No.	103
		Drawn	vh/mgf	Rev.	E

Shakespeare Statue:  
Conservator to repair statue, replacing rusting framework in non-ferrous metal, repairing leadwork and redecorating to match original colour.

New lighting on stalks to replace existing.

New bird netting on completion of works, held away from statue to avoid abrasion.

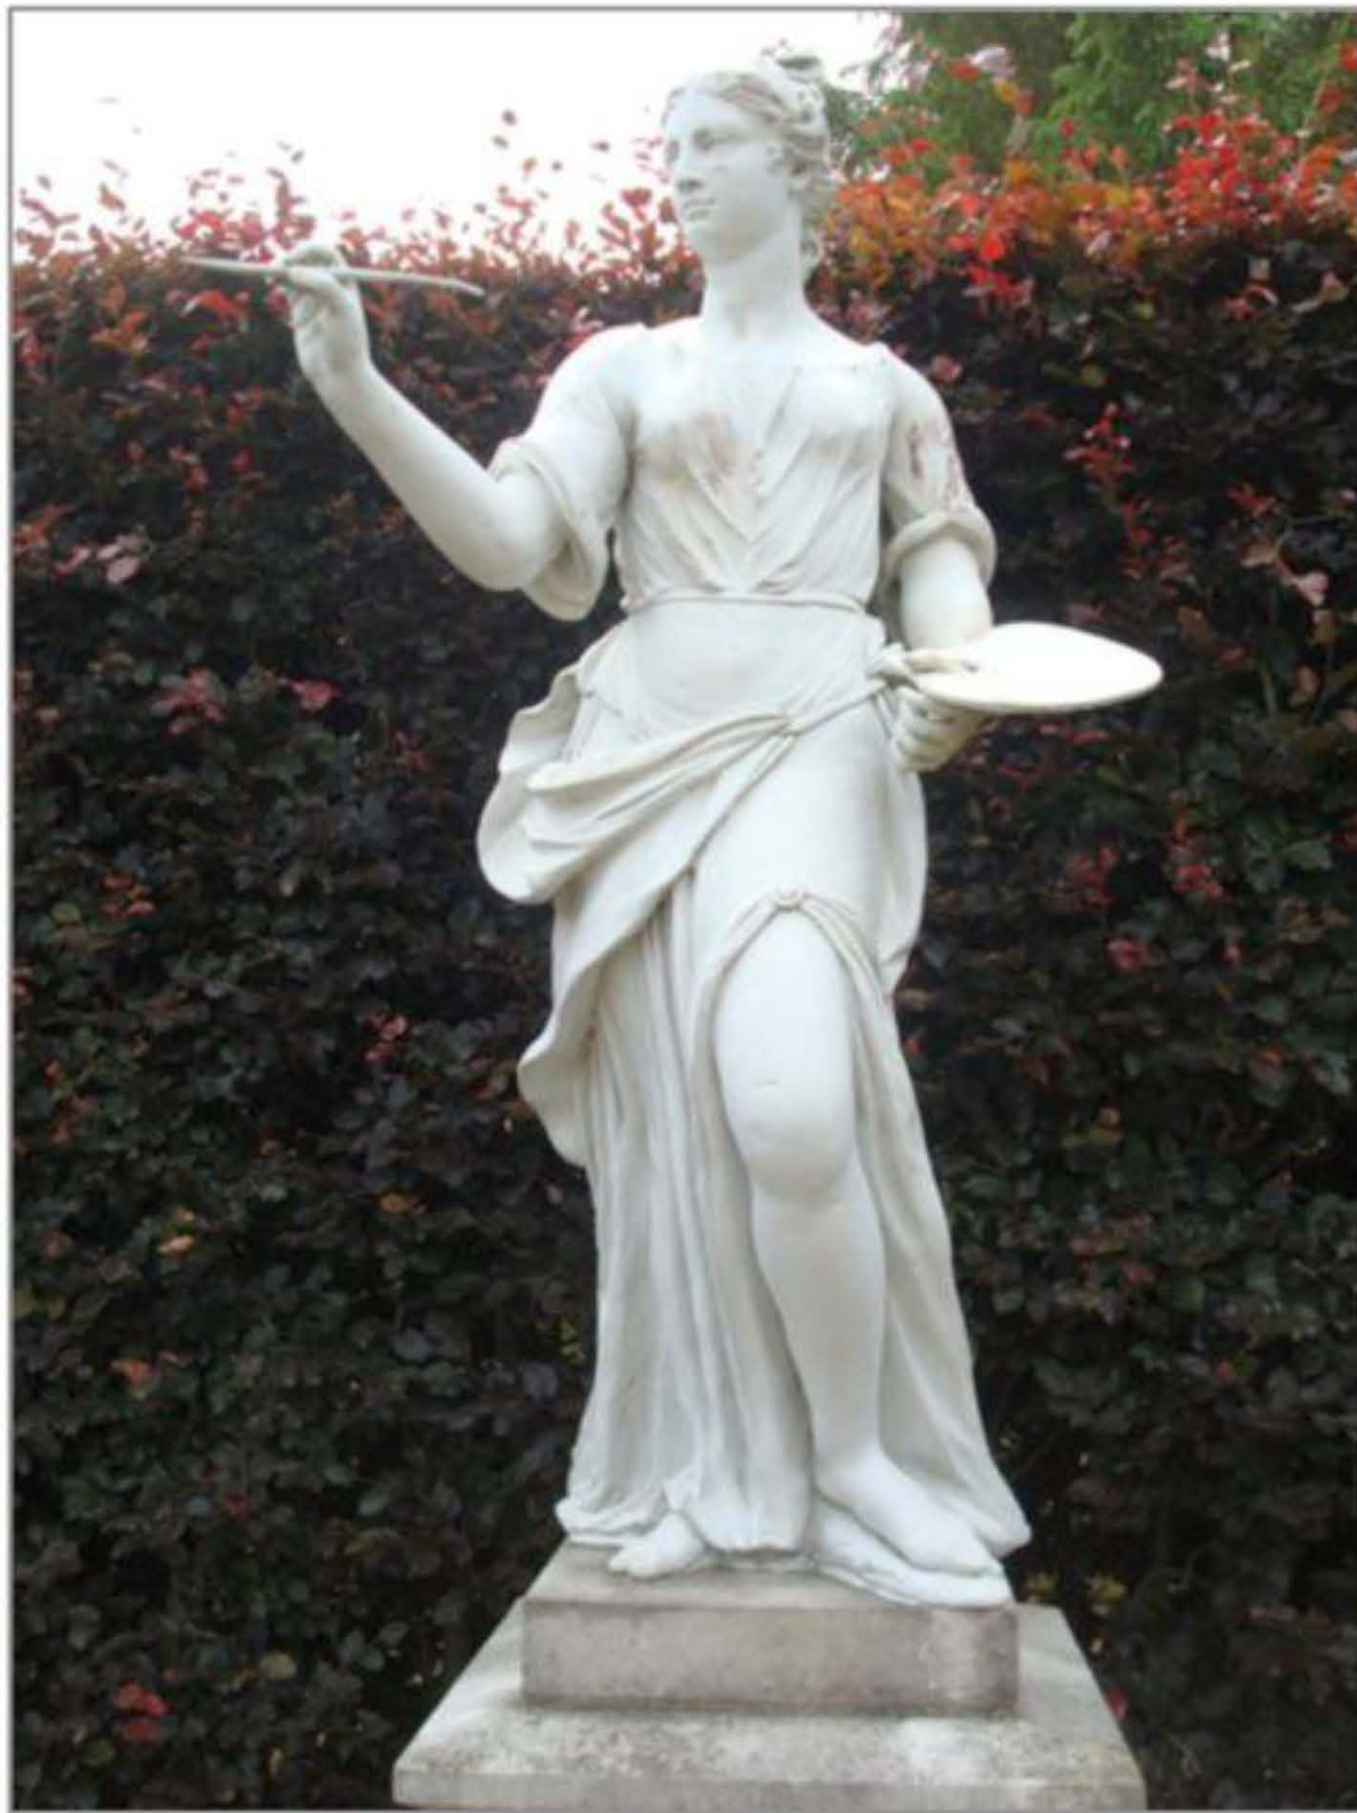
Anglesey Abbey, lead Allegory of Painting, John Cheere, mid-18<sup>th</sup>-century, painted to resemble marble

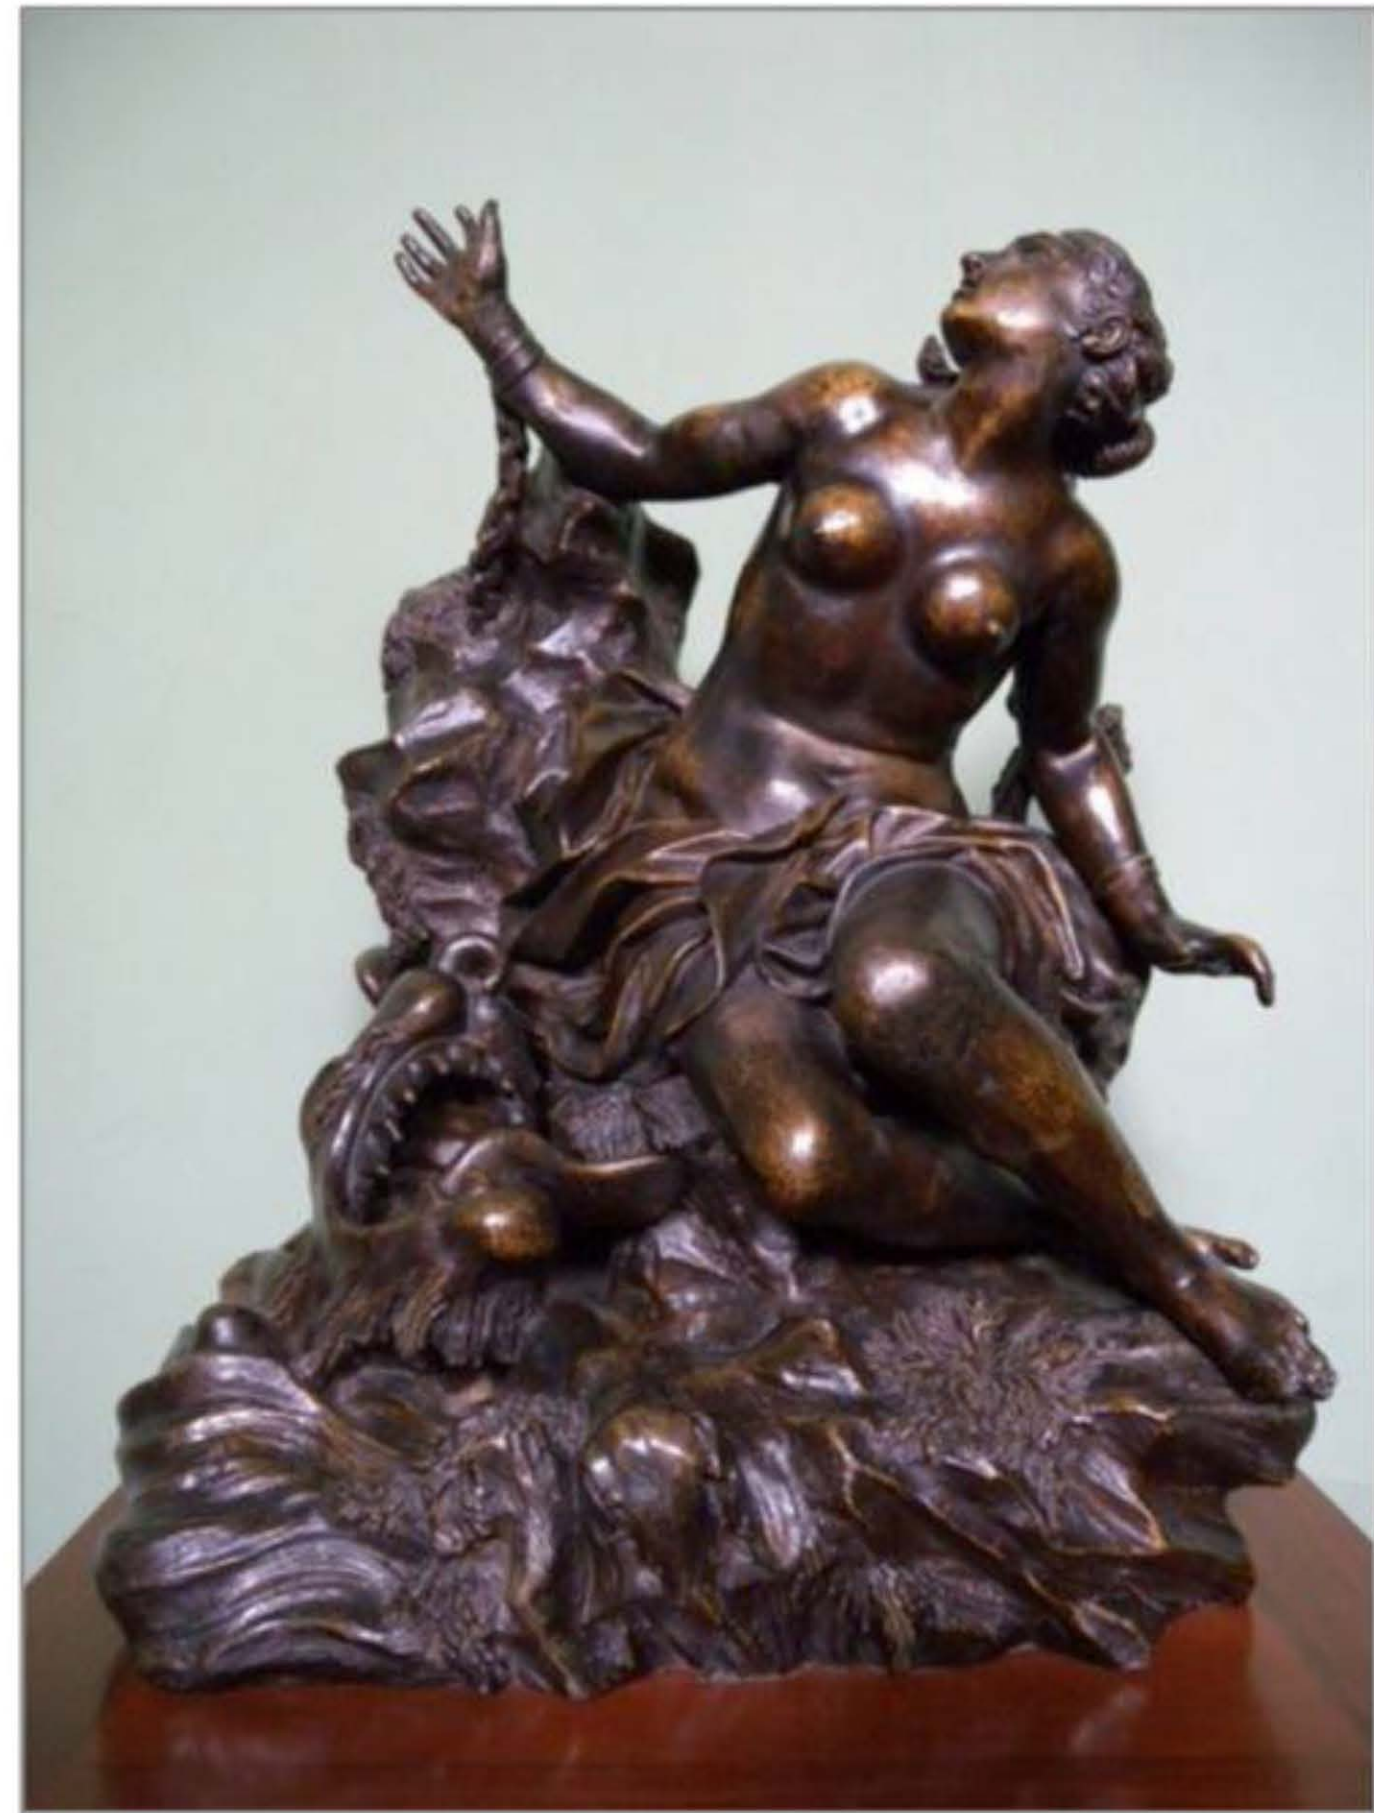
Interior lead Andromeda at Osterley, late 17<sup>th</sup>-century, retaining its original bronzed finish, which was created using an early metallic paint, finished with a glaze

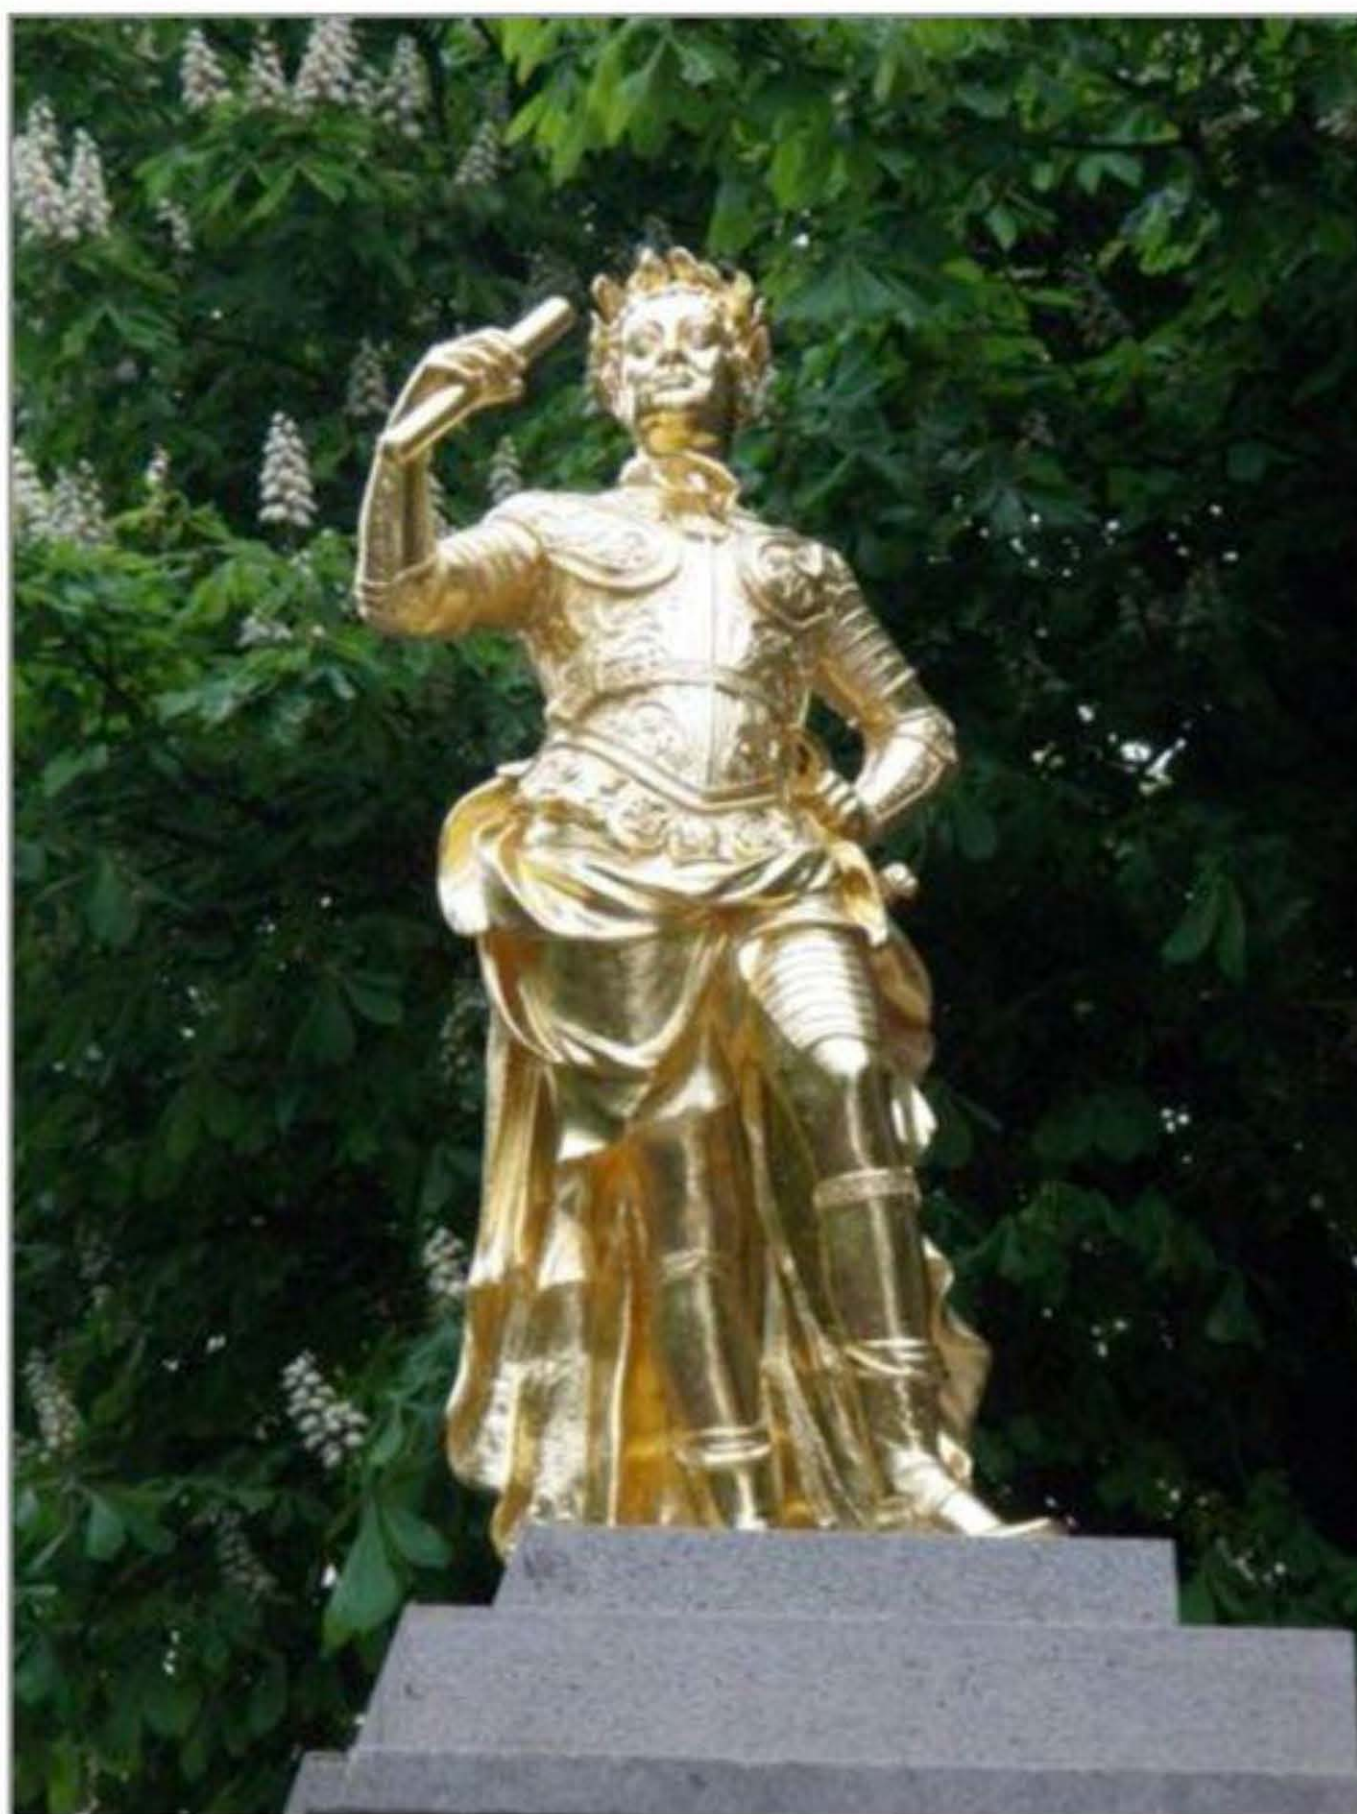
St Helier, lead George II, John Cheere, 1751, leaf gilded

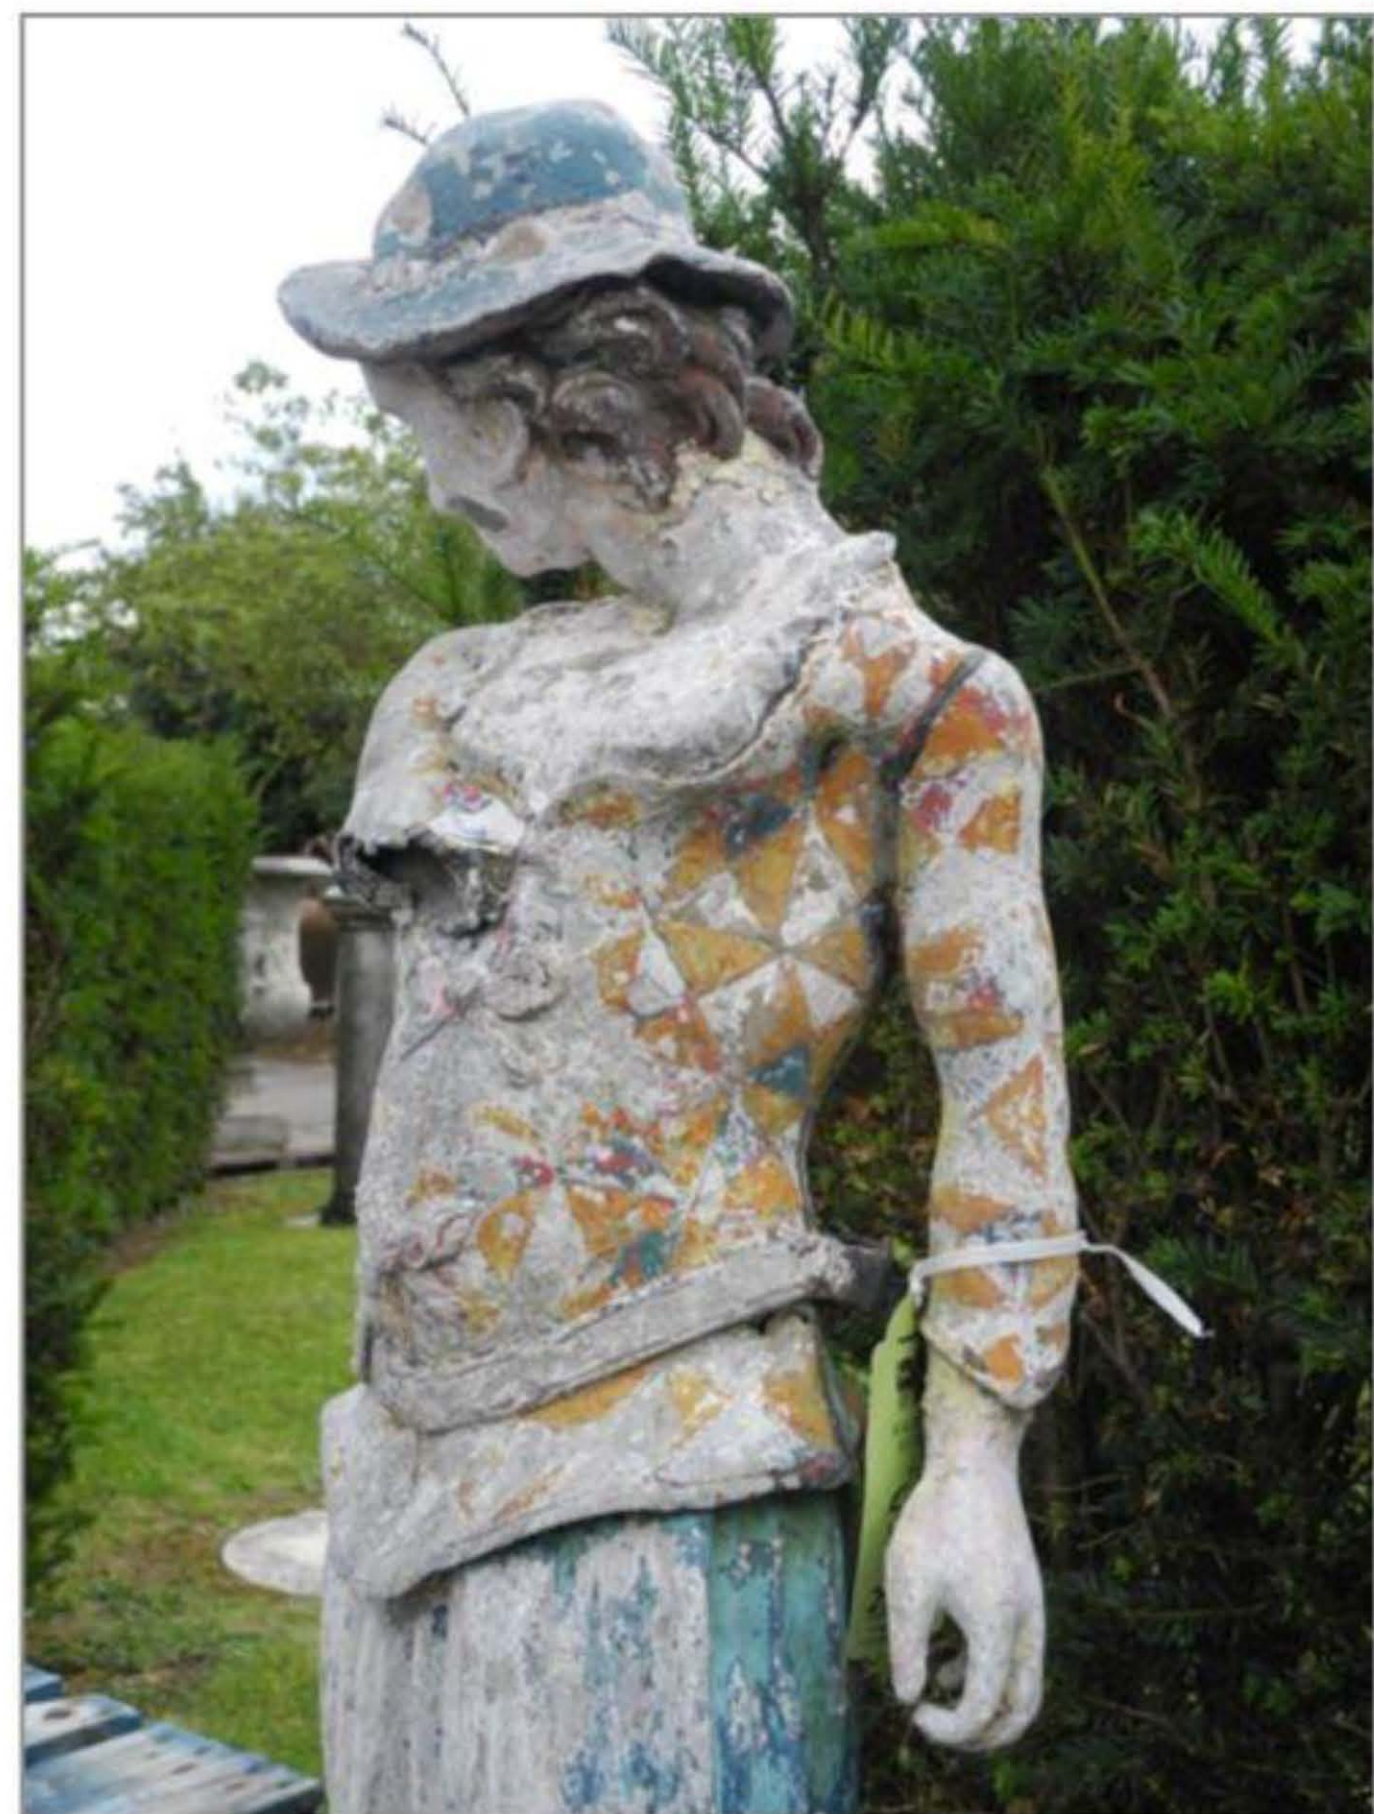
A lead 'Columbine' painted in polychrome. Private collection.

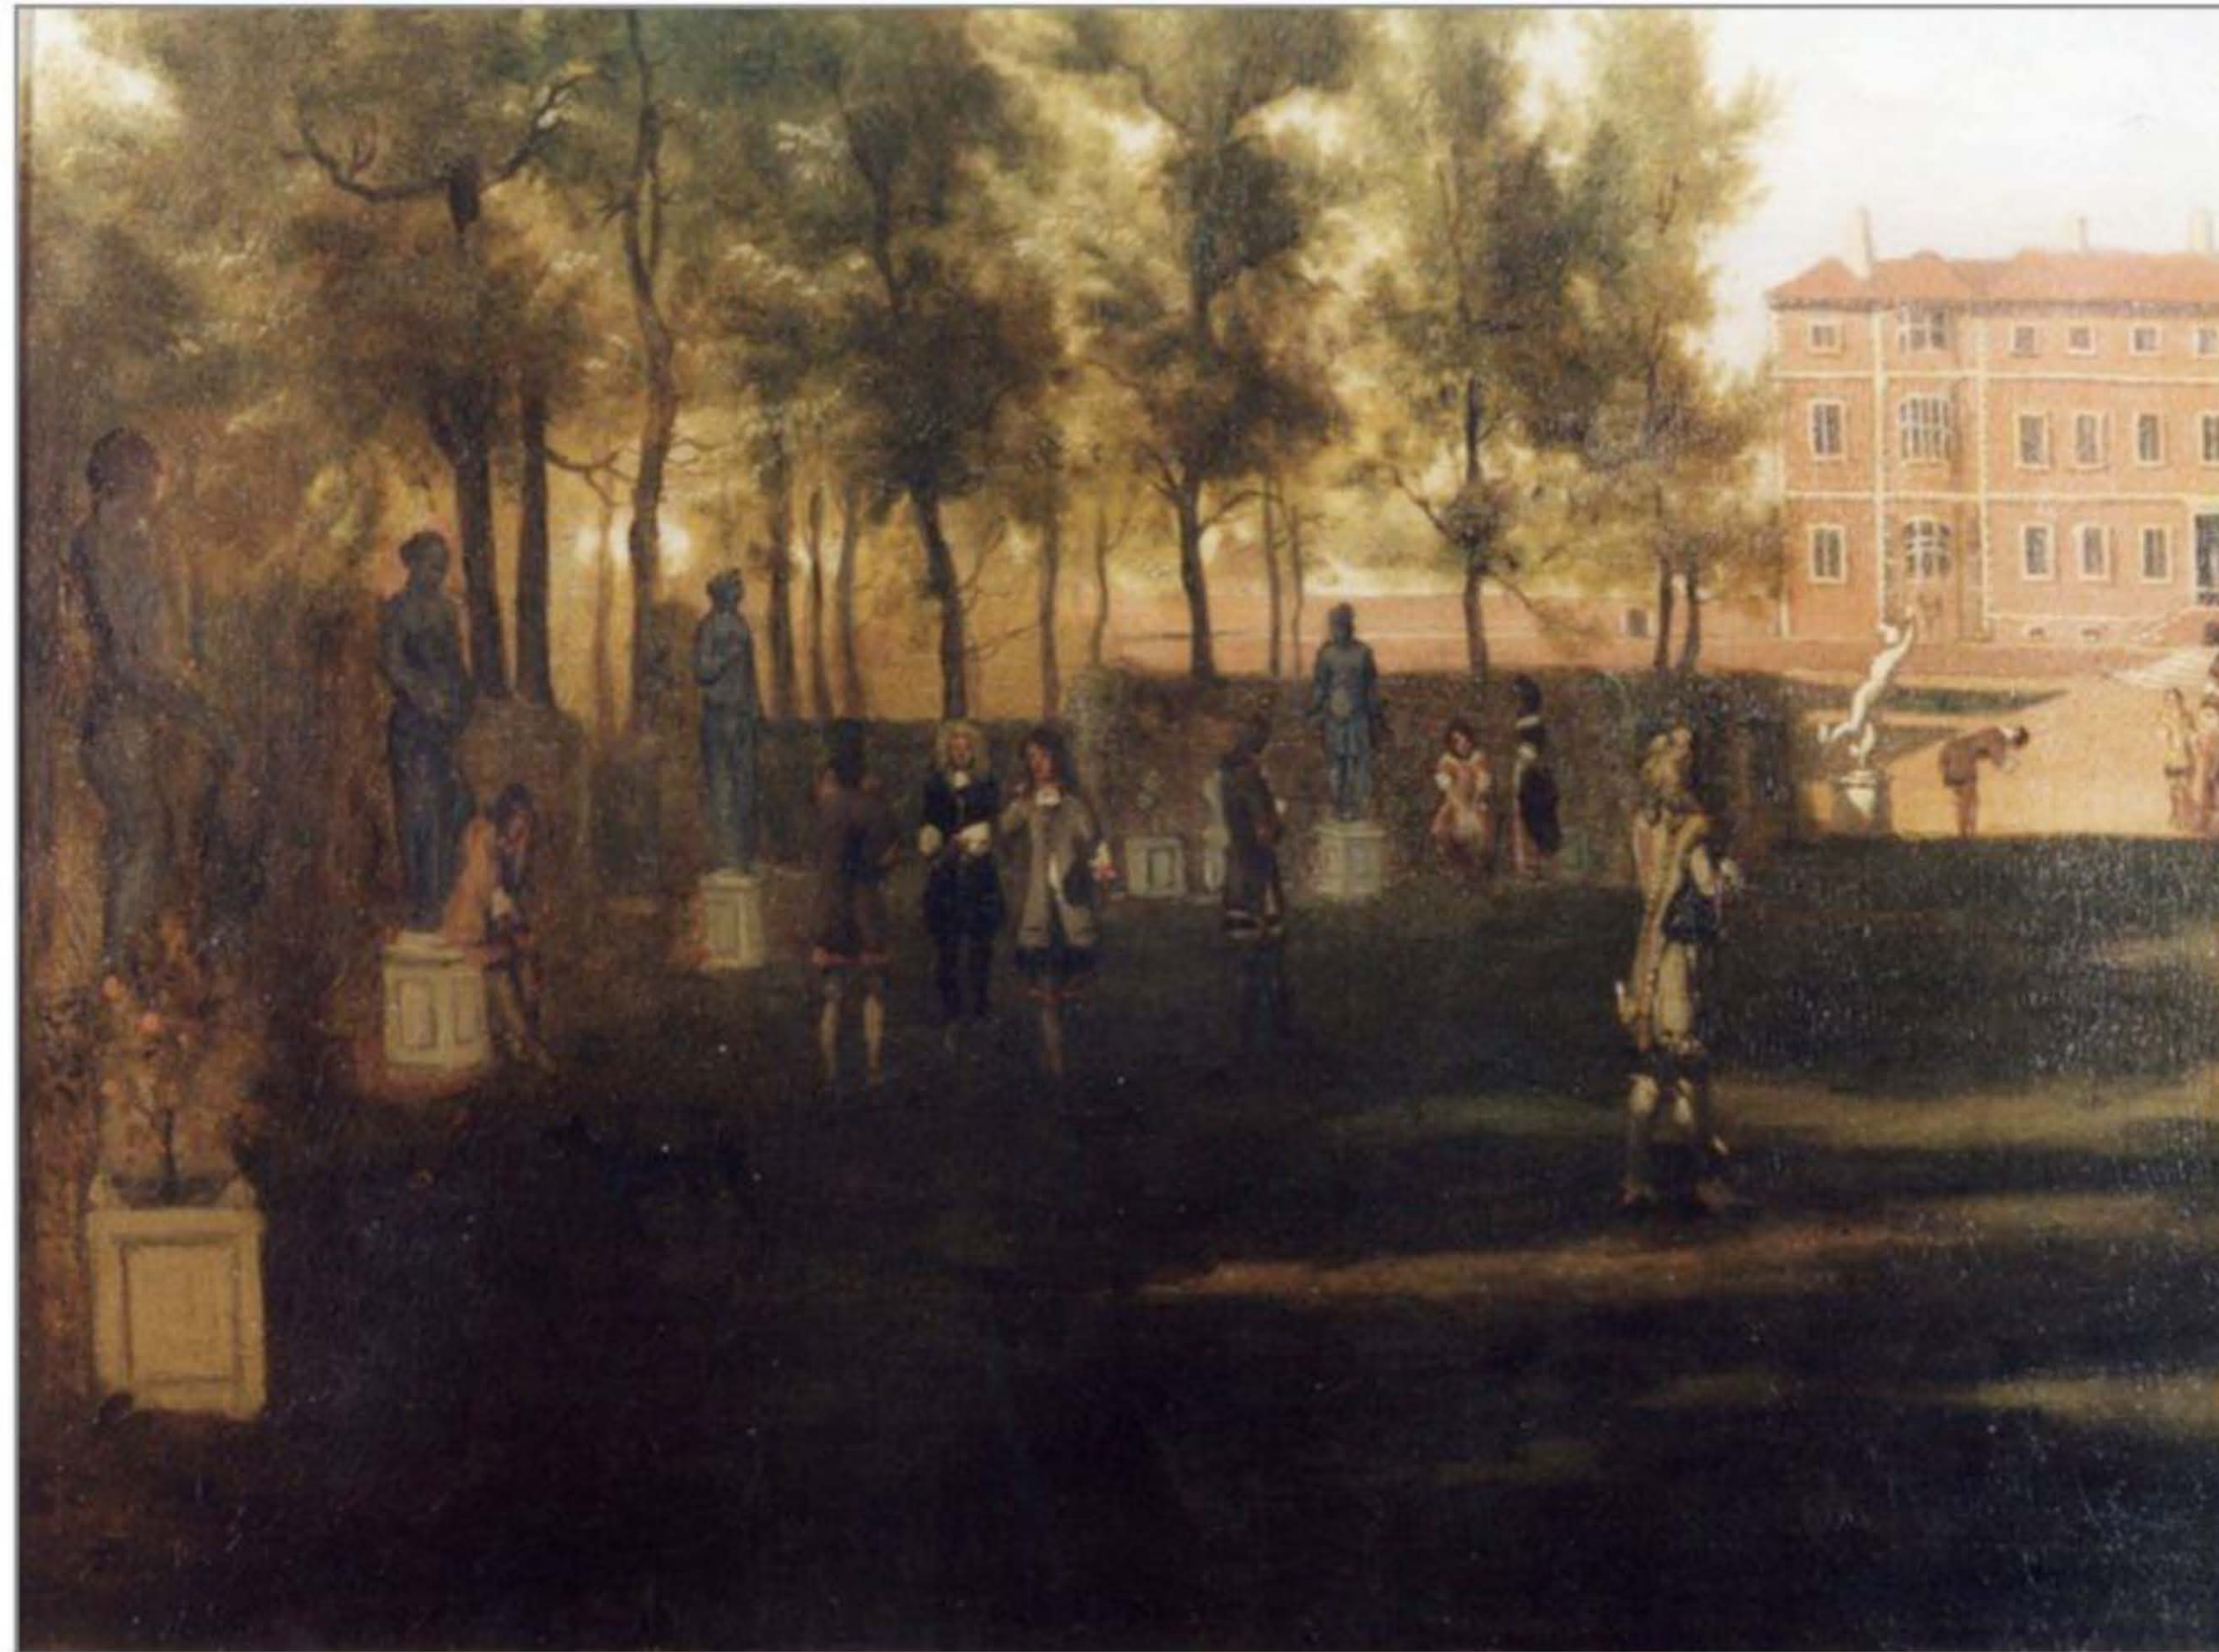
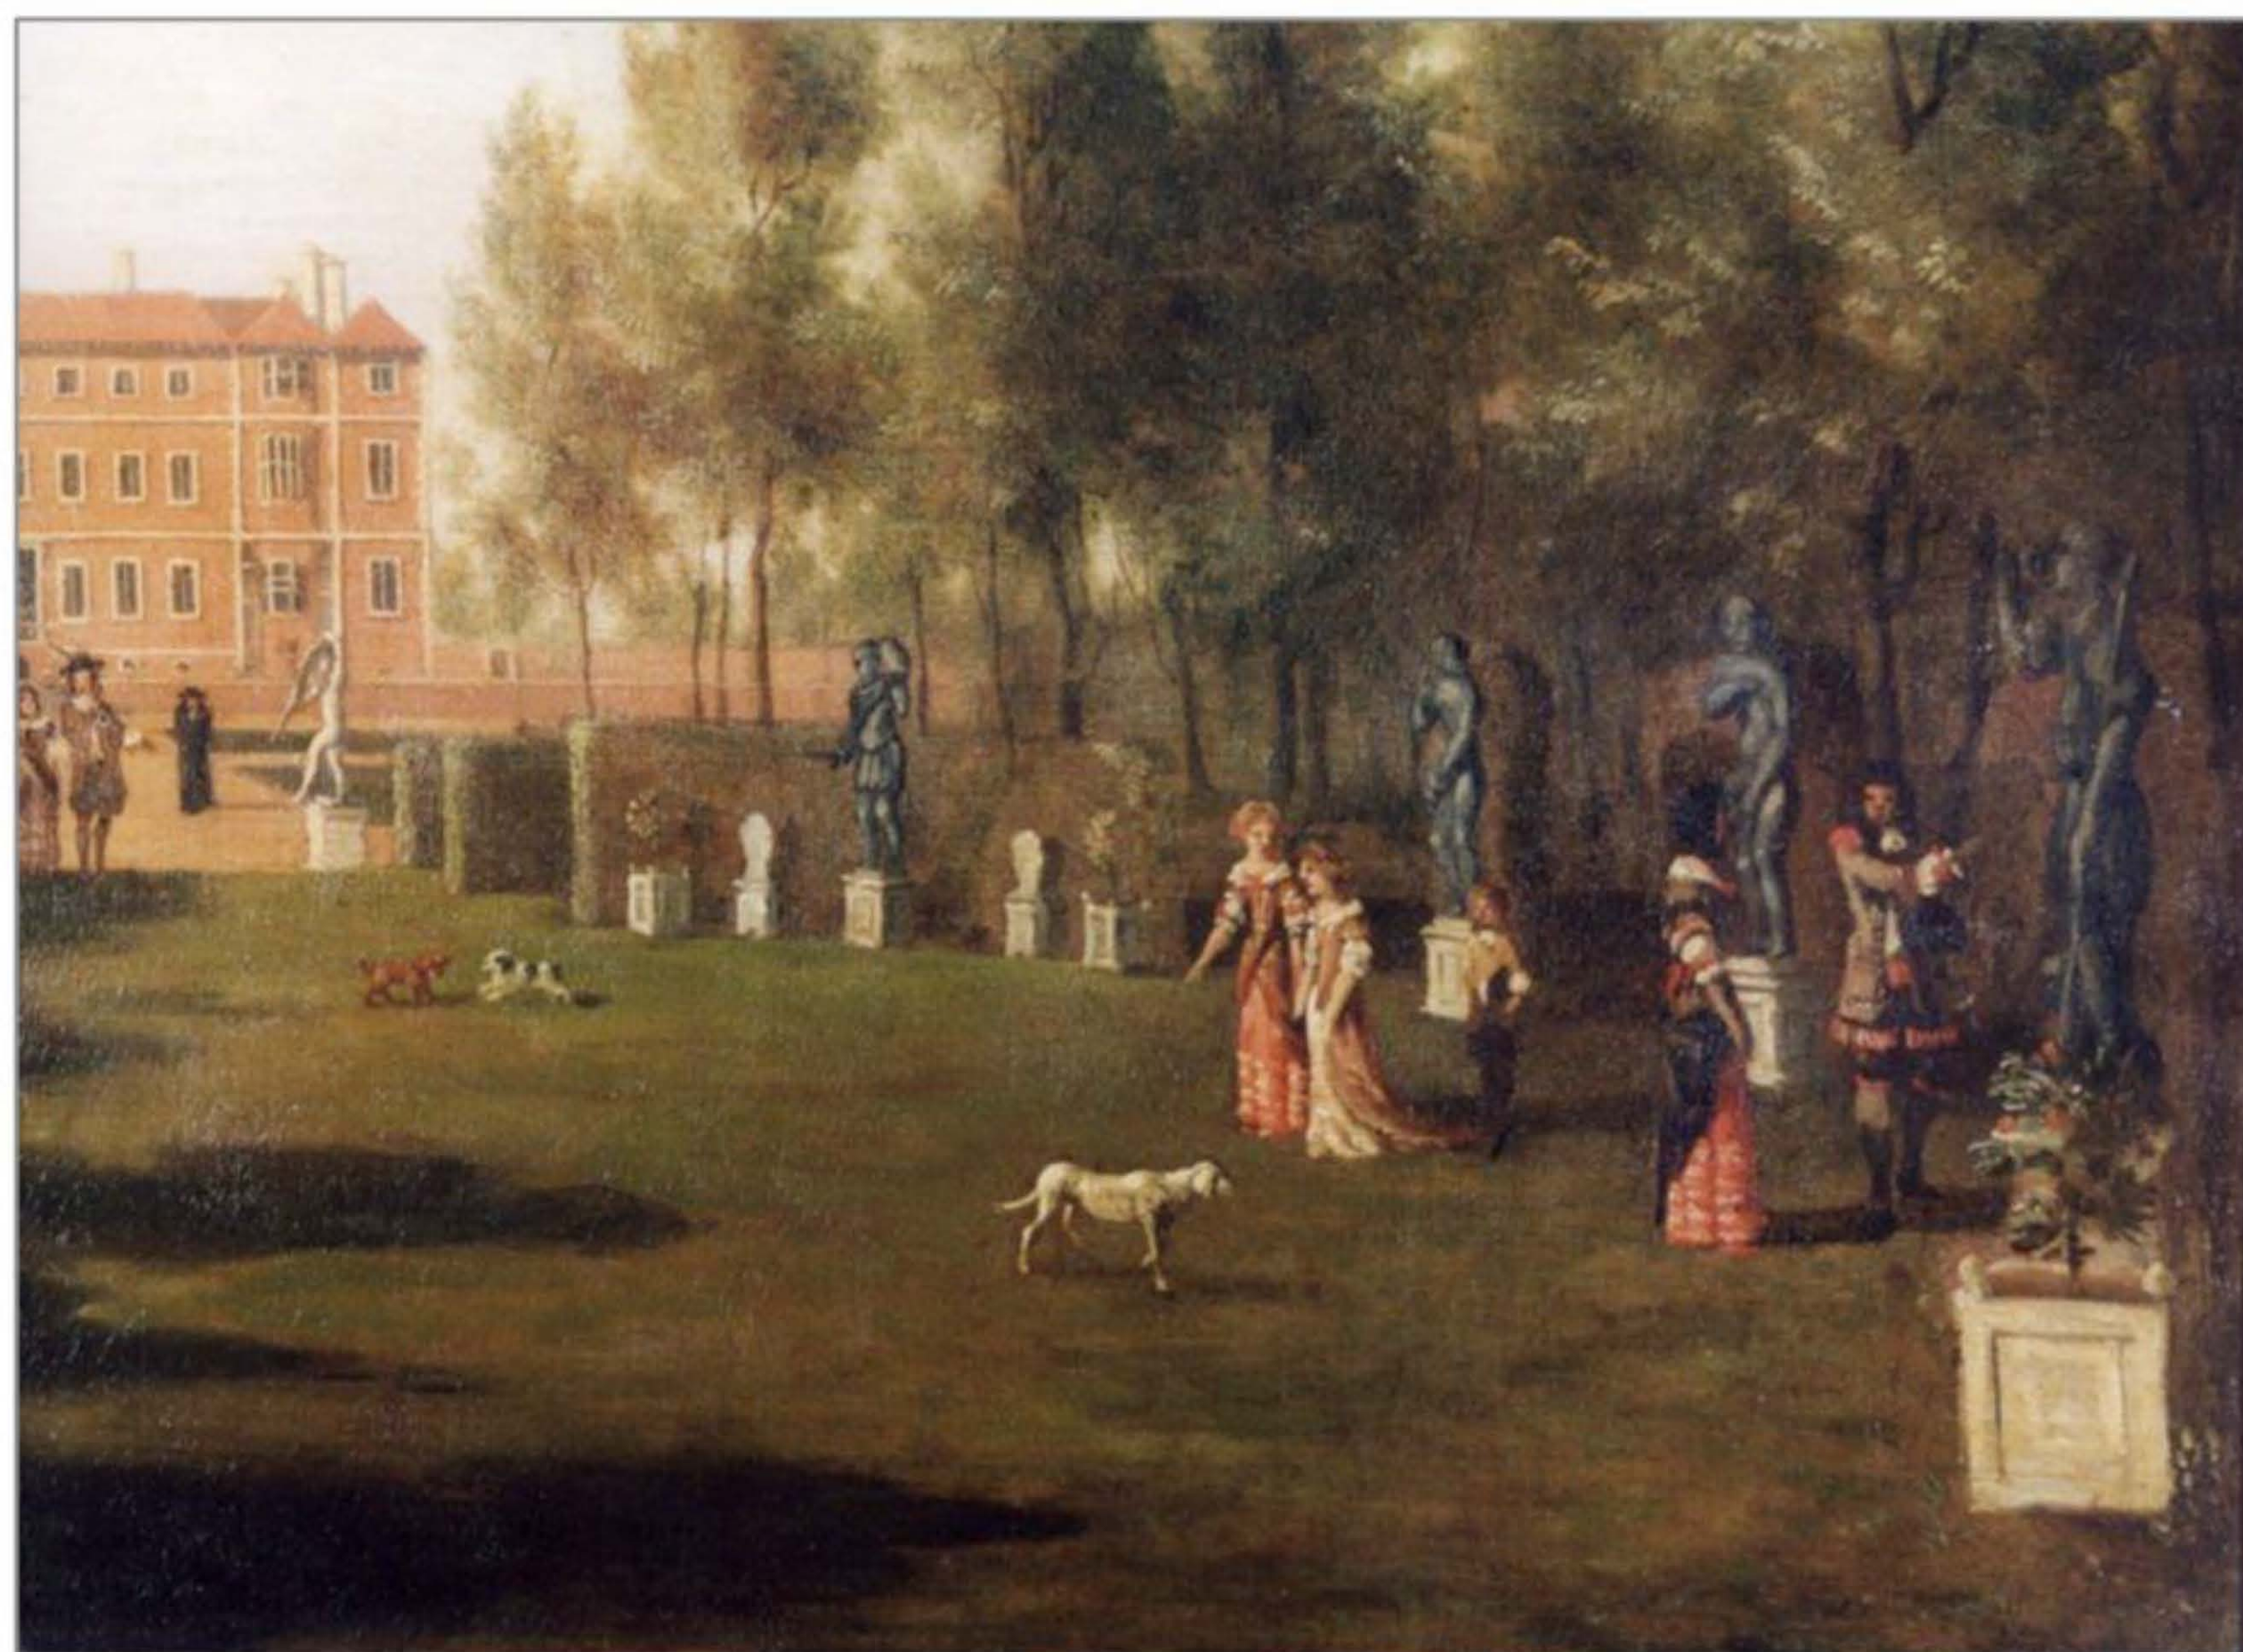
Above, details of Dankaerts' 1675 painting of the gardens at Ham House showing oiled leads on each side and two white-painted leads in the centre, which have now been replicated for the gardens, as seen overleaf

The written evidence mentioned above for the variety of surface finishes is confirmed by numerous contemporary and earlier paintings of gardens, examples of which are shown below.
