STRATFORD TOWN HALL

LISTED BUILDING CONSENT APPLICATION  
FOR CONSERVATION OF SHAKESPEARE STATUE

HERITAGE STATEMENT

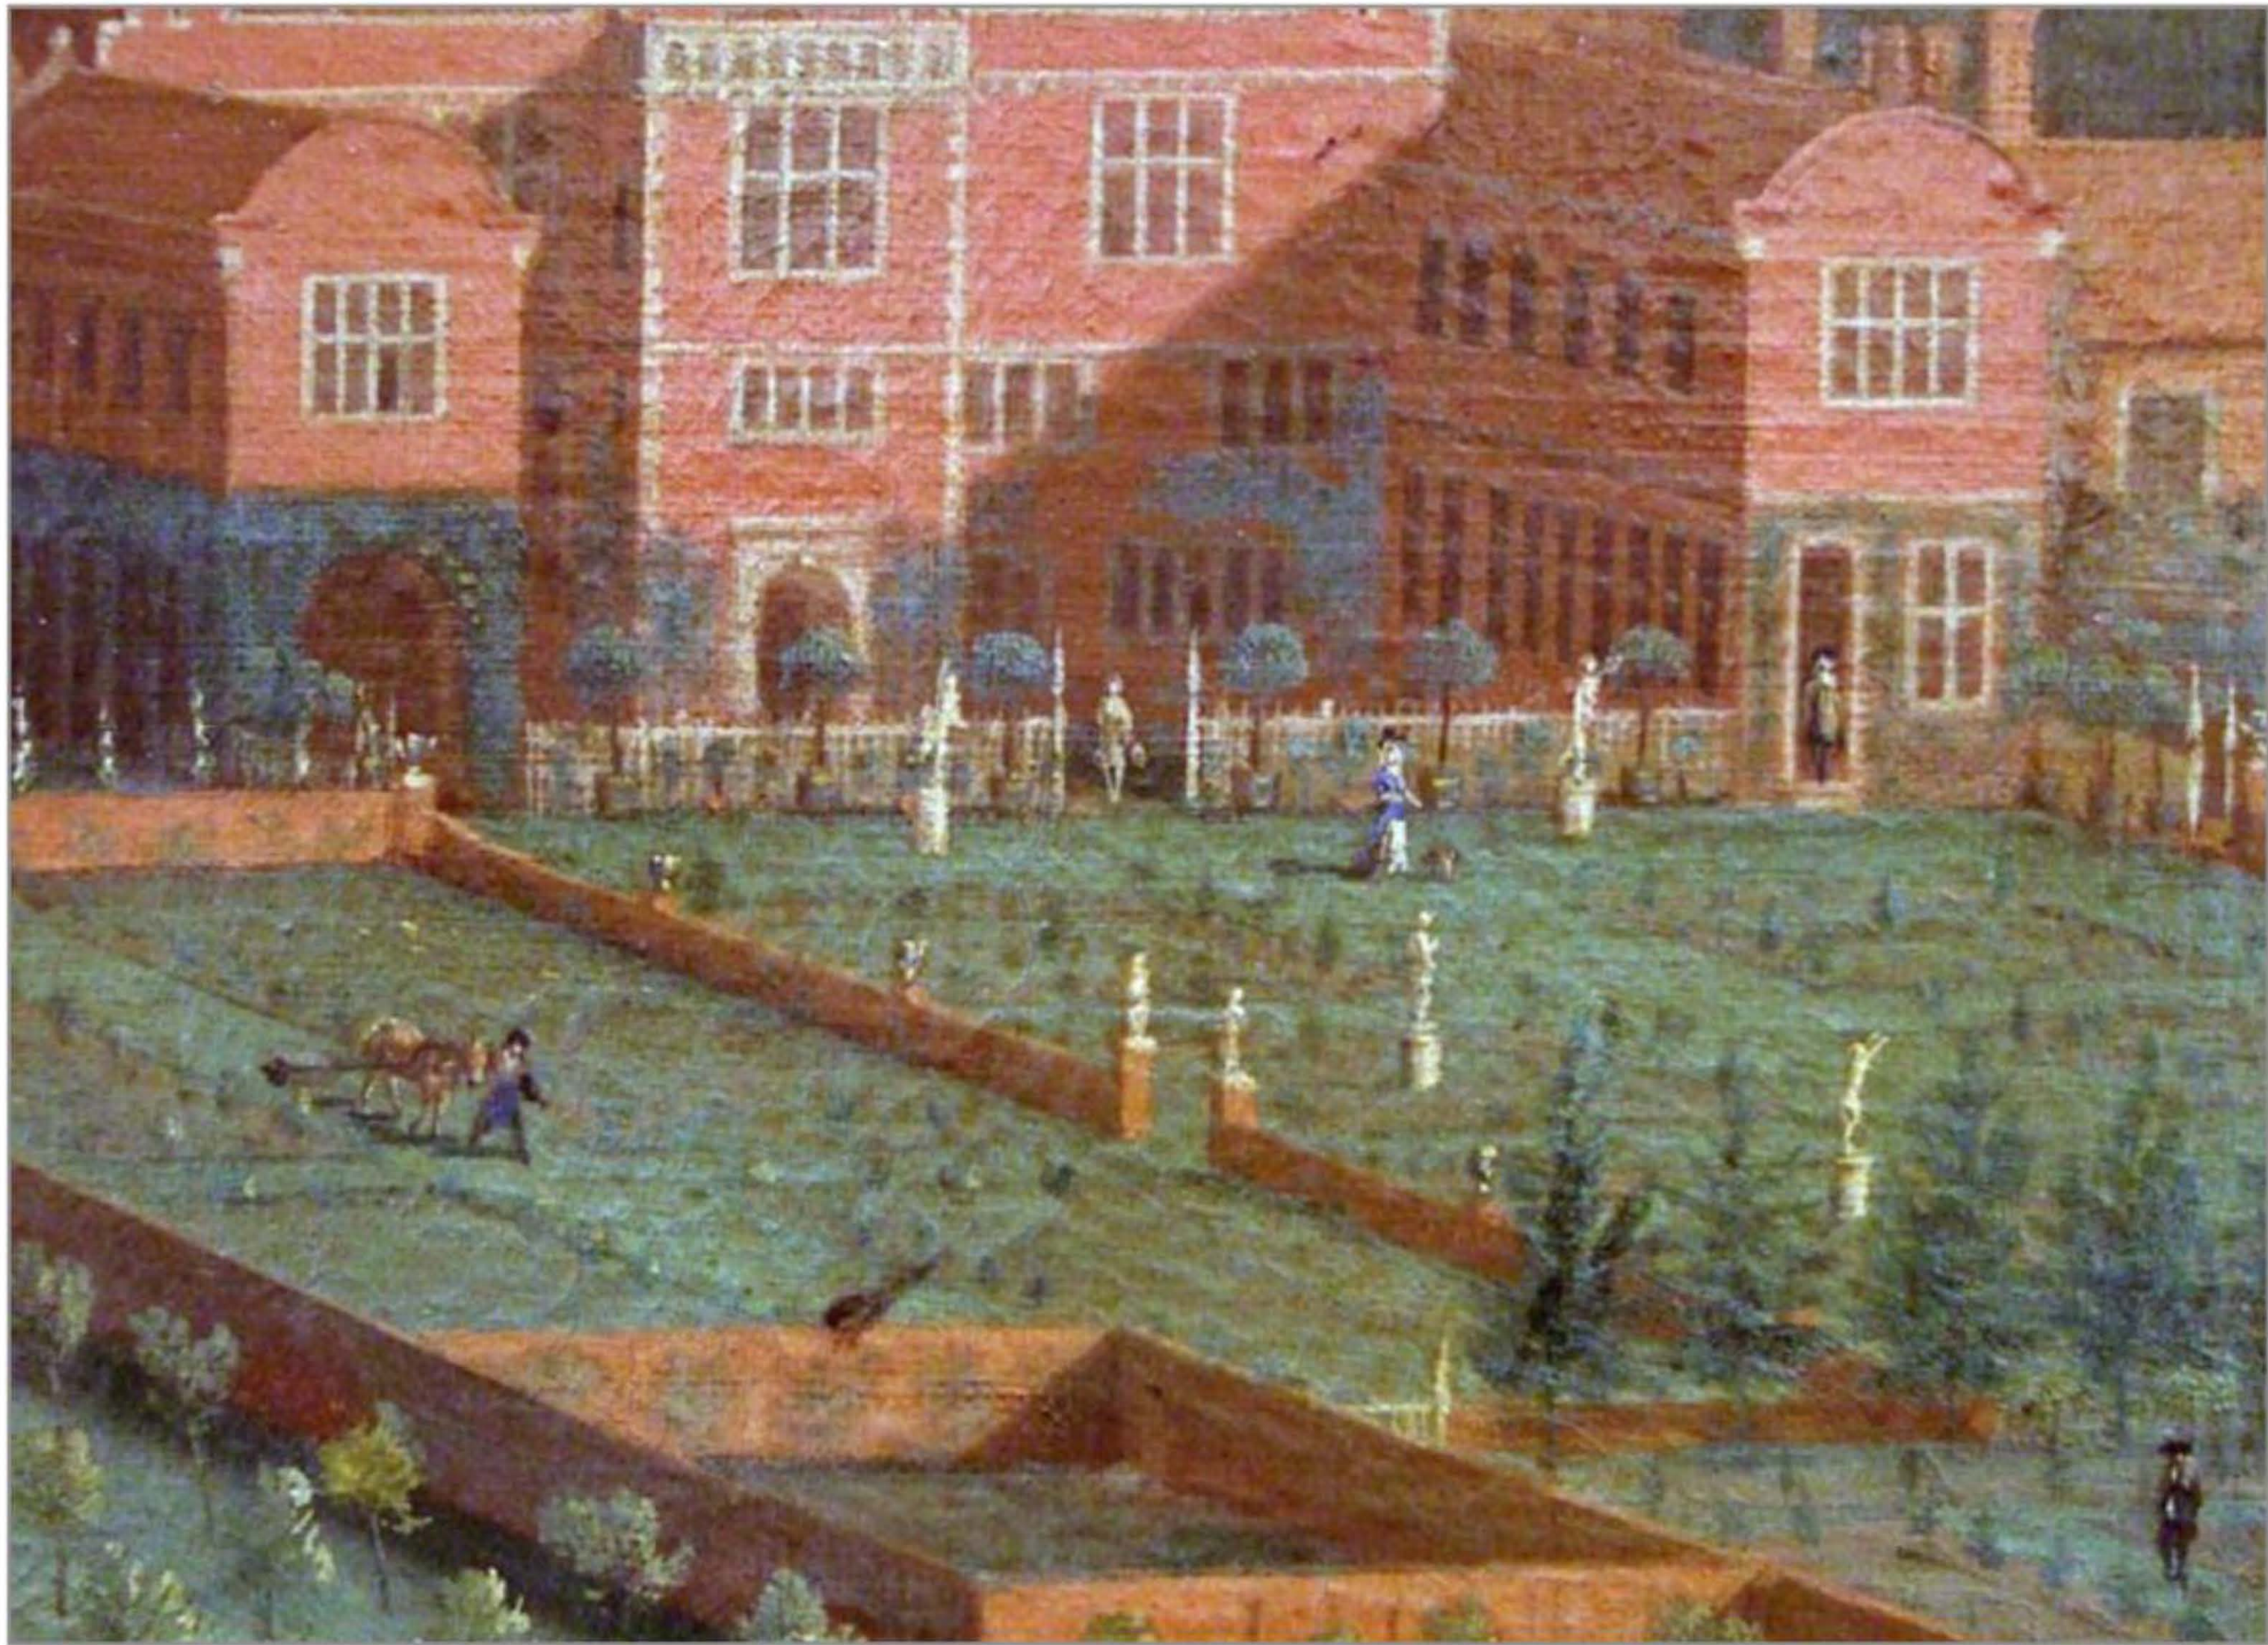
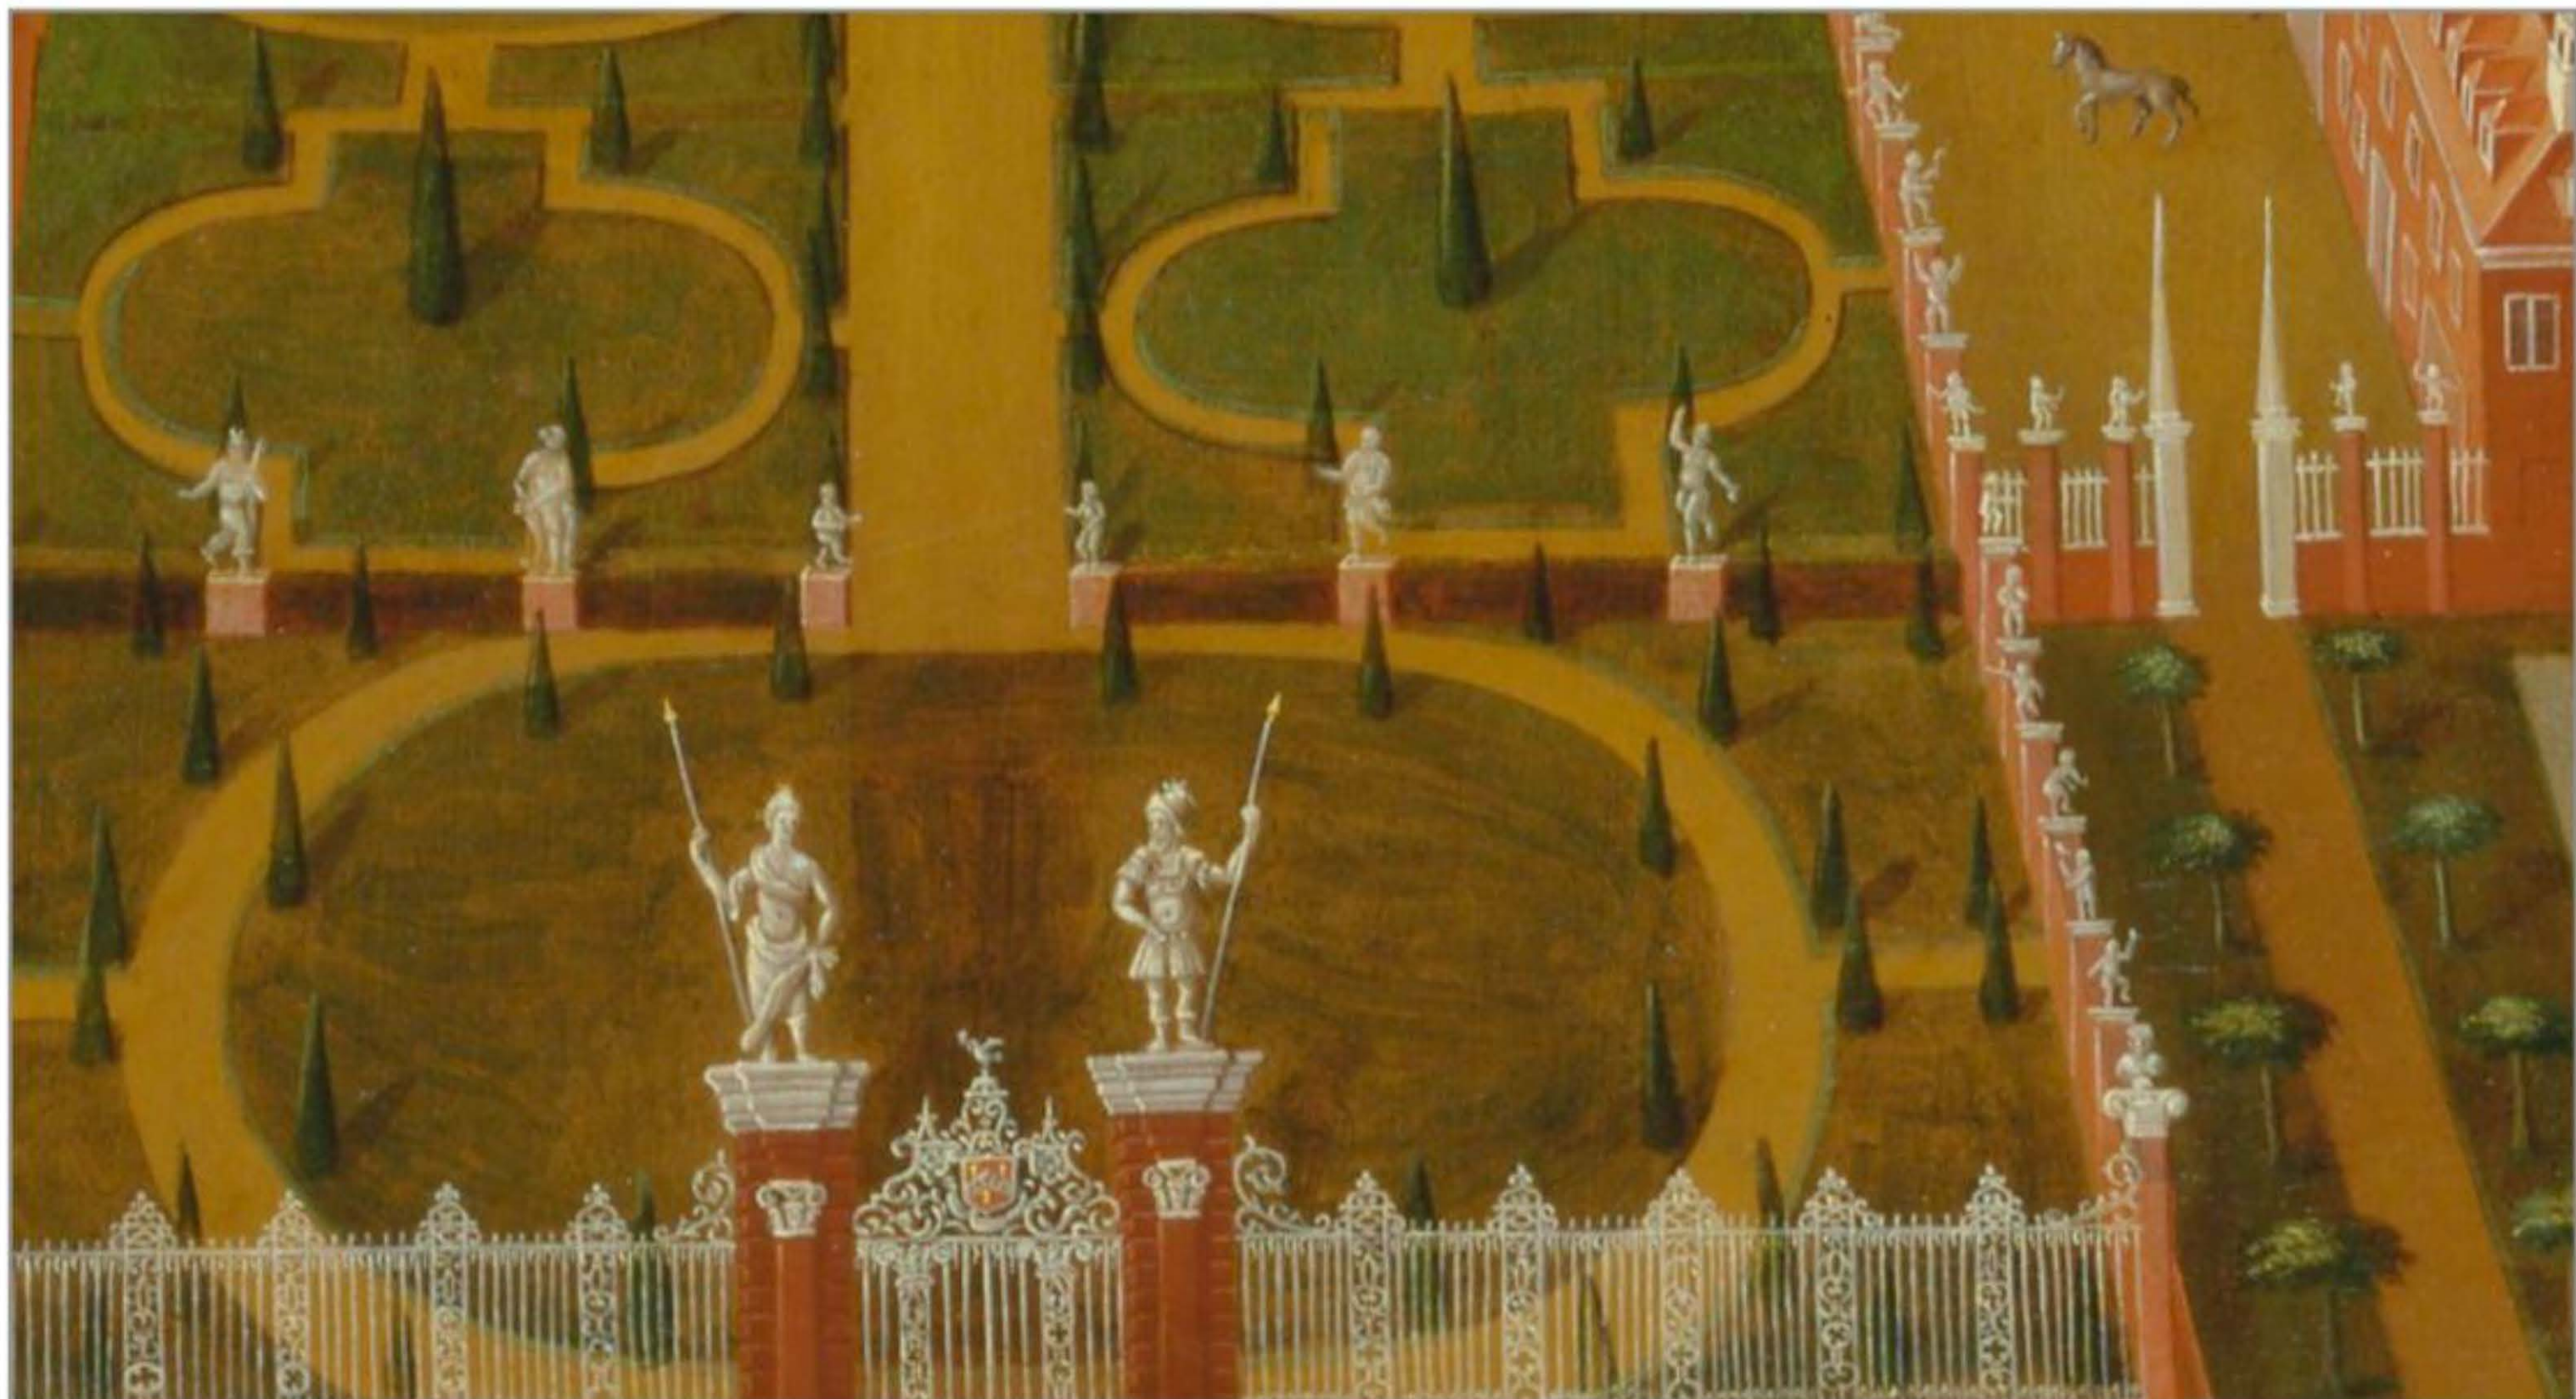
Above, detail of a painting of Bifrons Park, Kent (English, c.1700). Below, detail of a painting of Denham Place by John Drapentier (fl.1674-1713). Both paintings show white-painted lead statuary (close examination of the statues reveals that in most cases their form could not have been achieved in stone). Both properties are now lost.

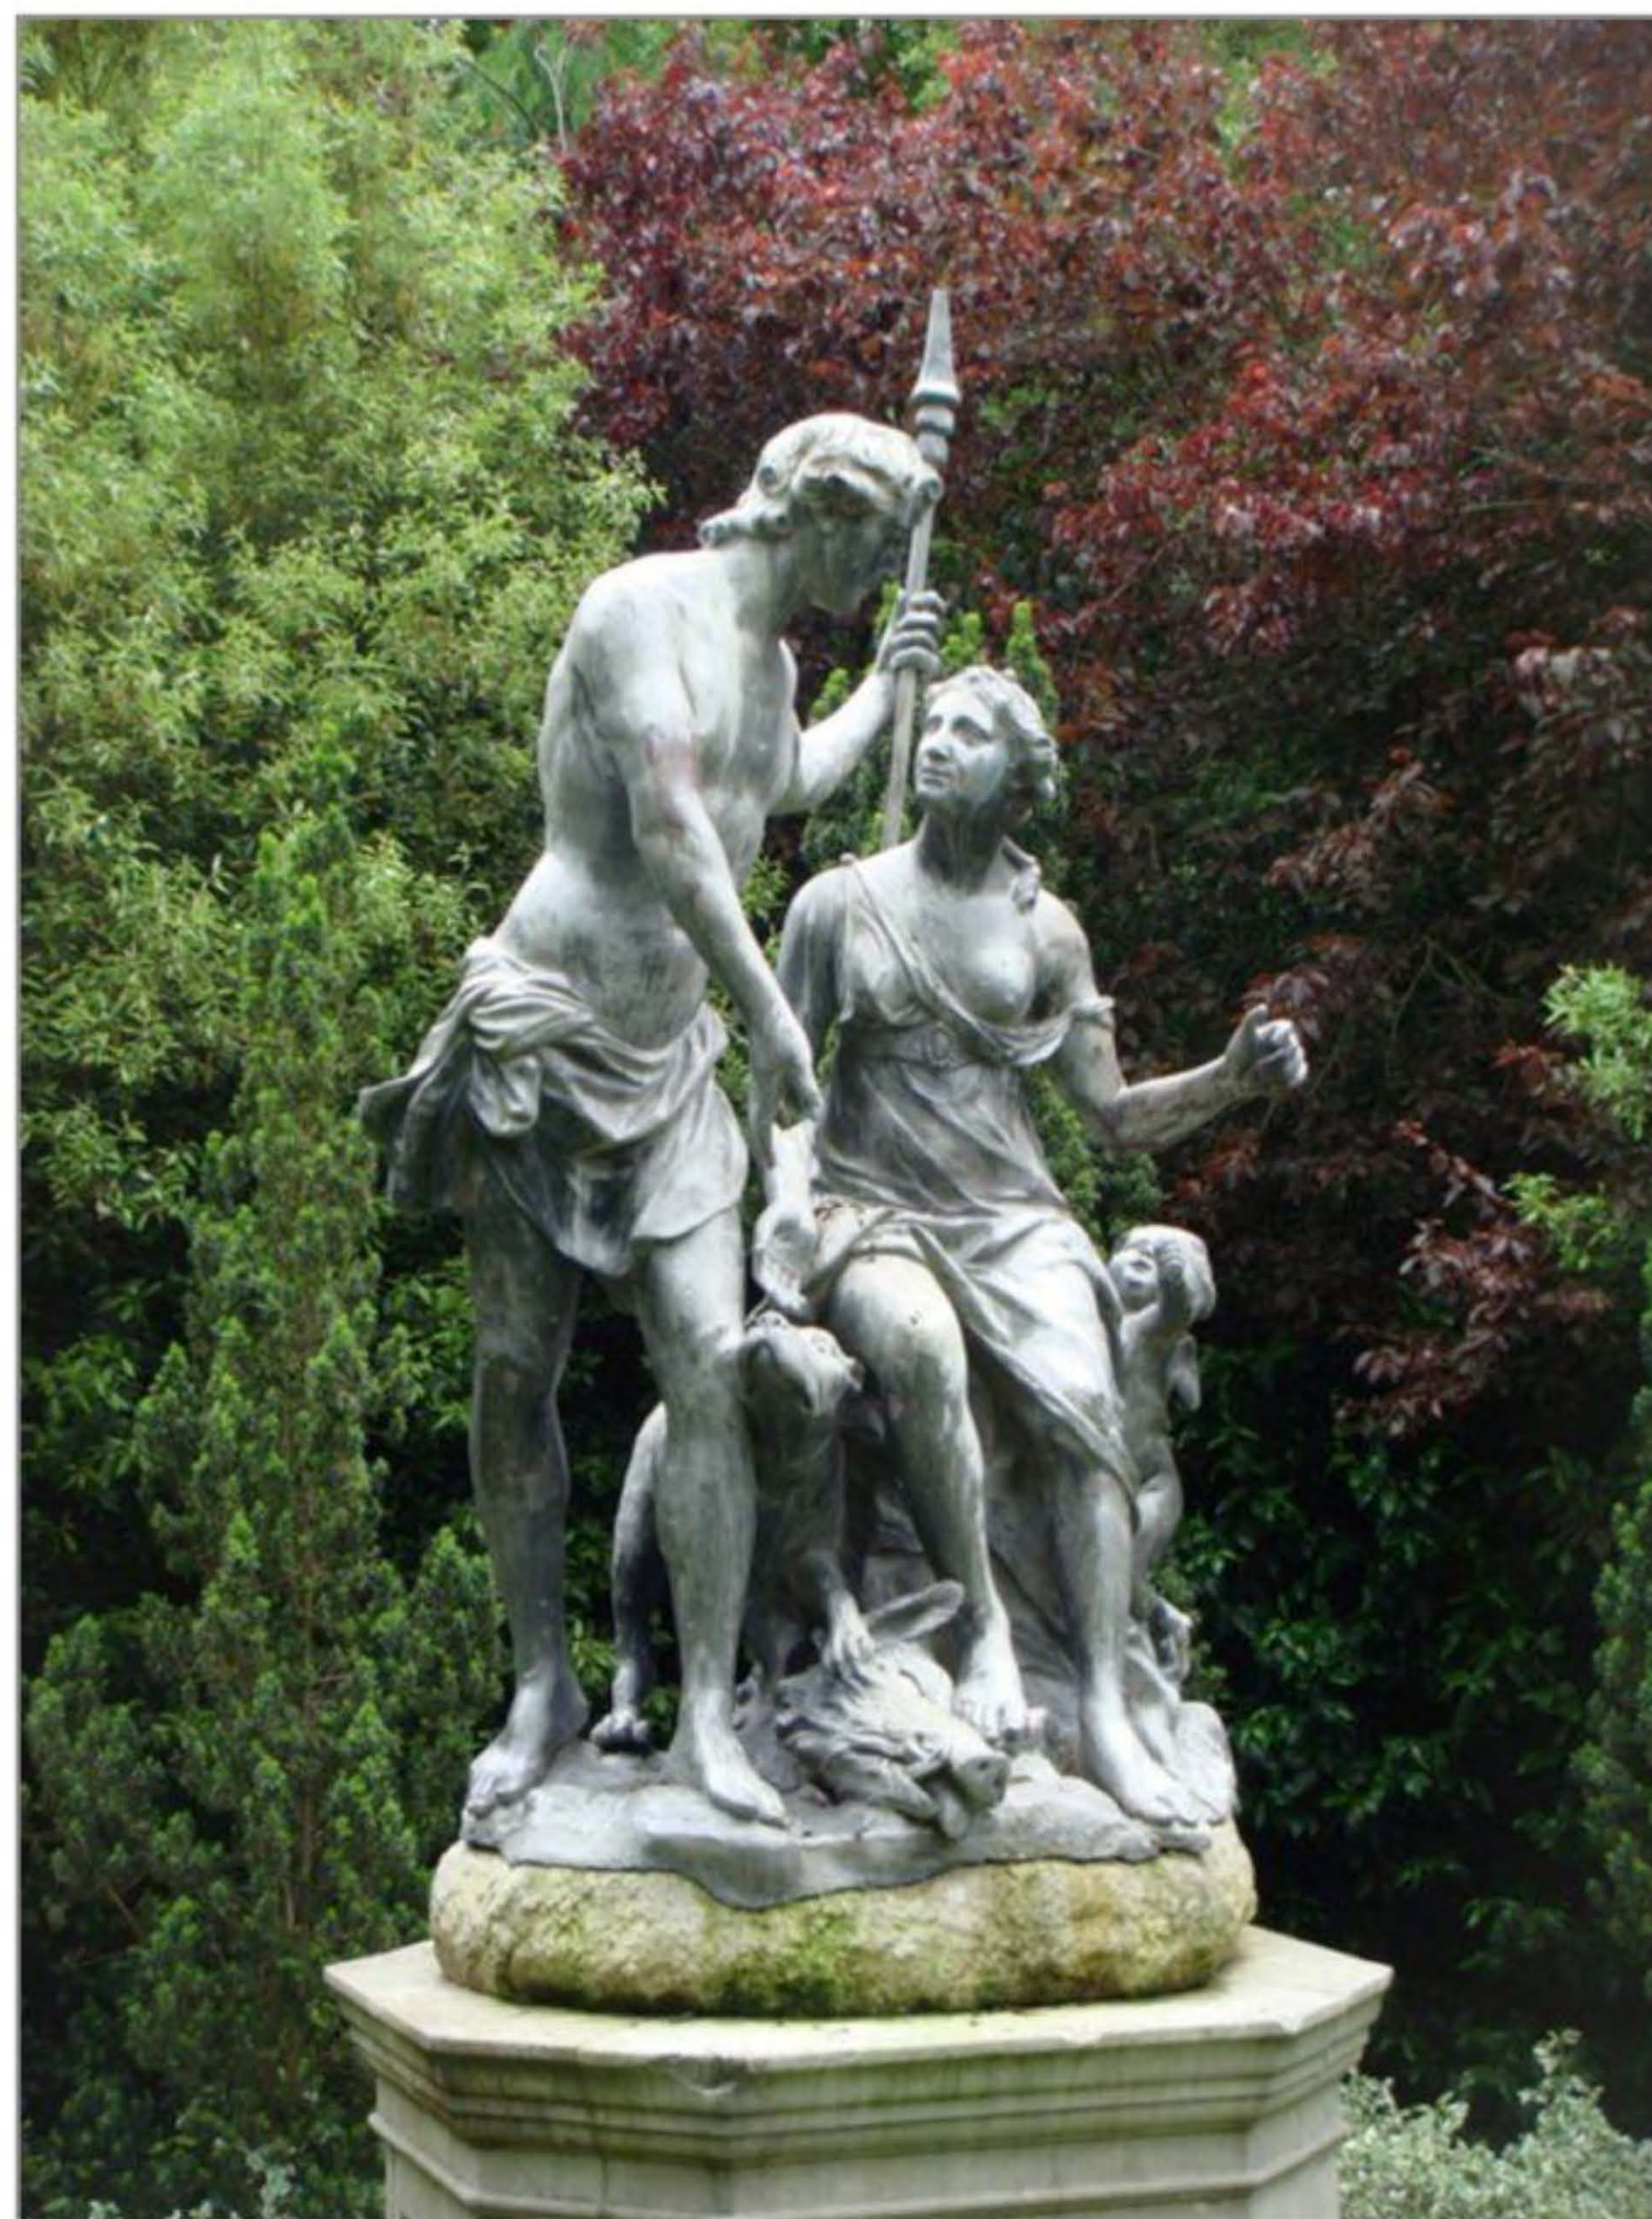
Natural patina on 'Olympian Courtship' (Diana and Endymion) at Anglesey Abbey

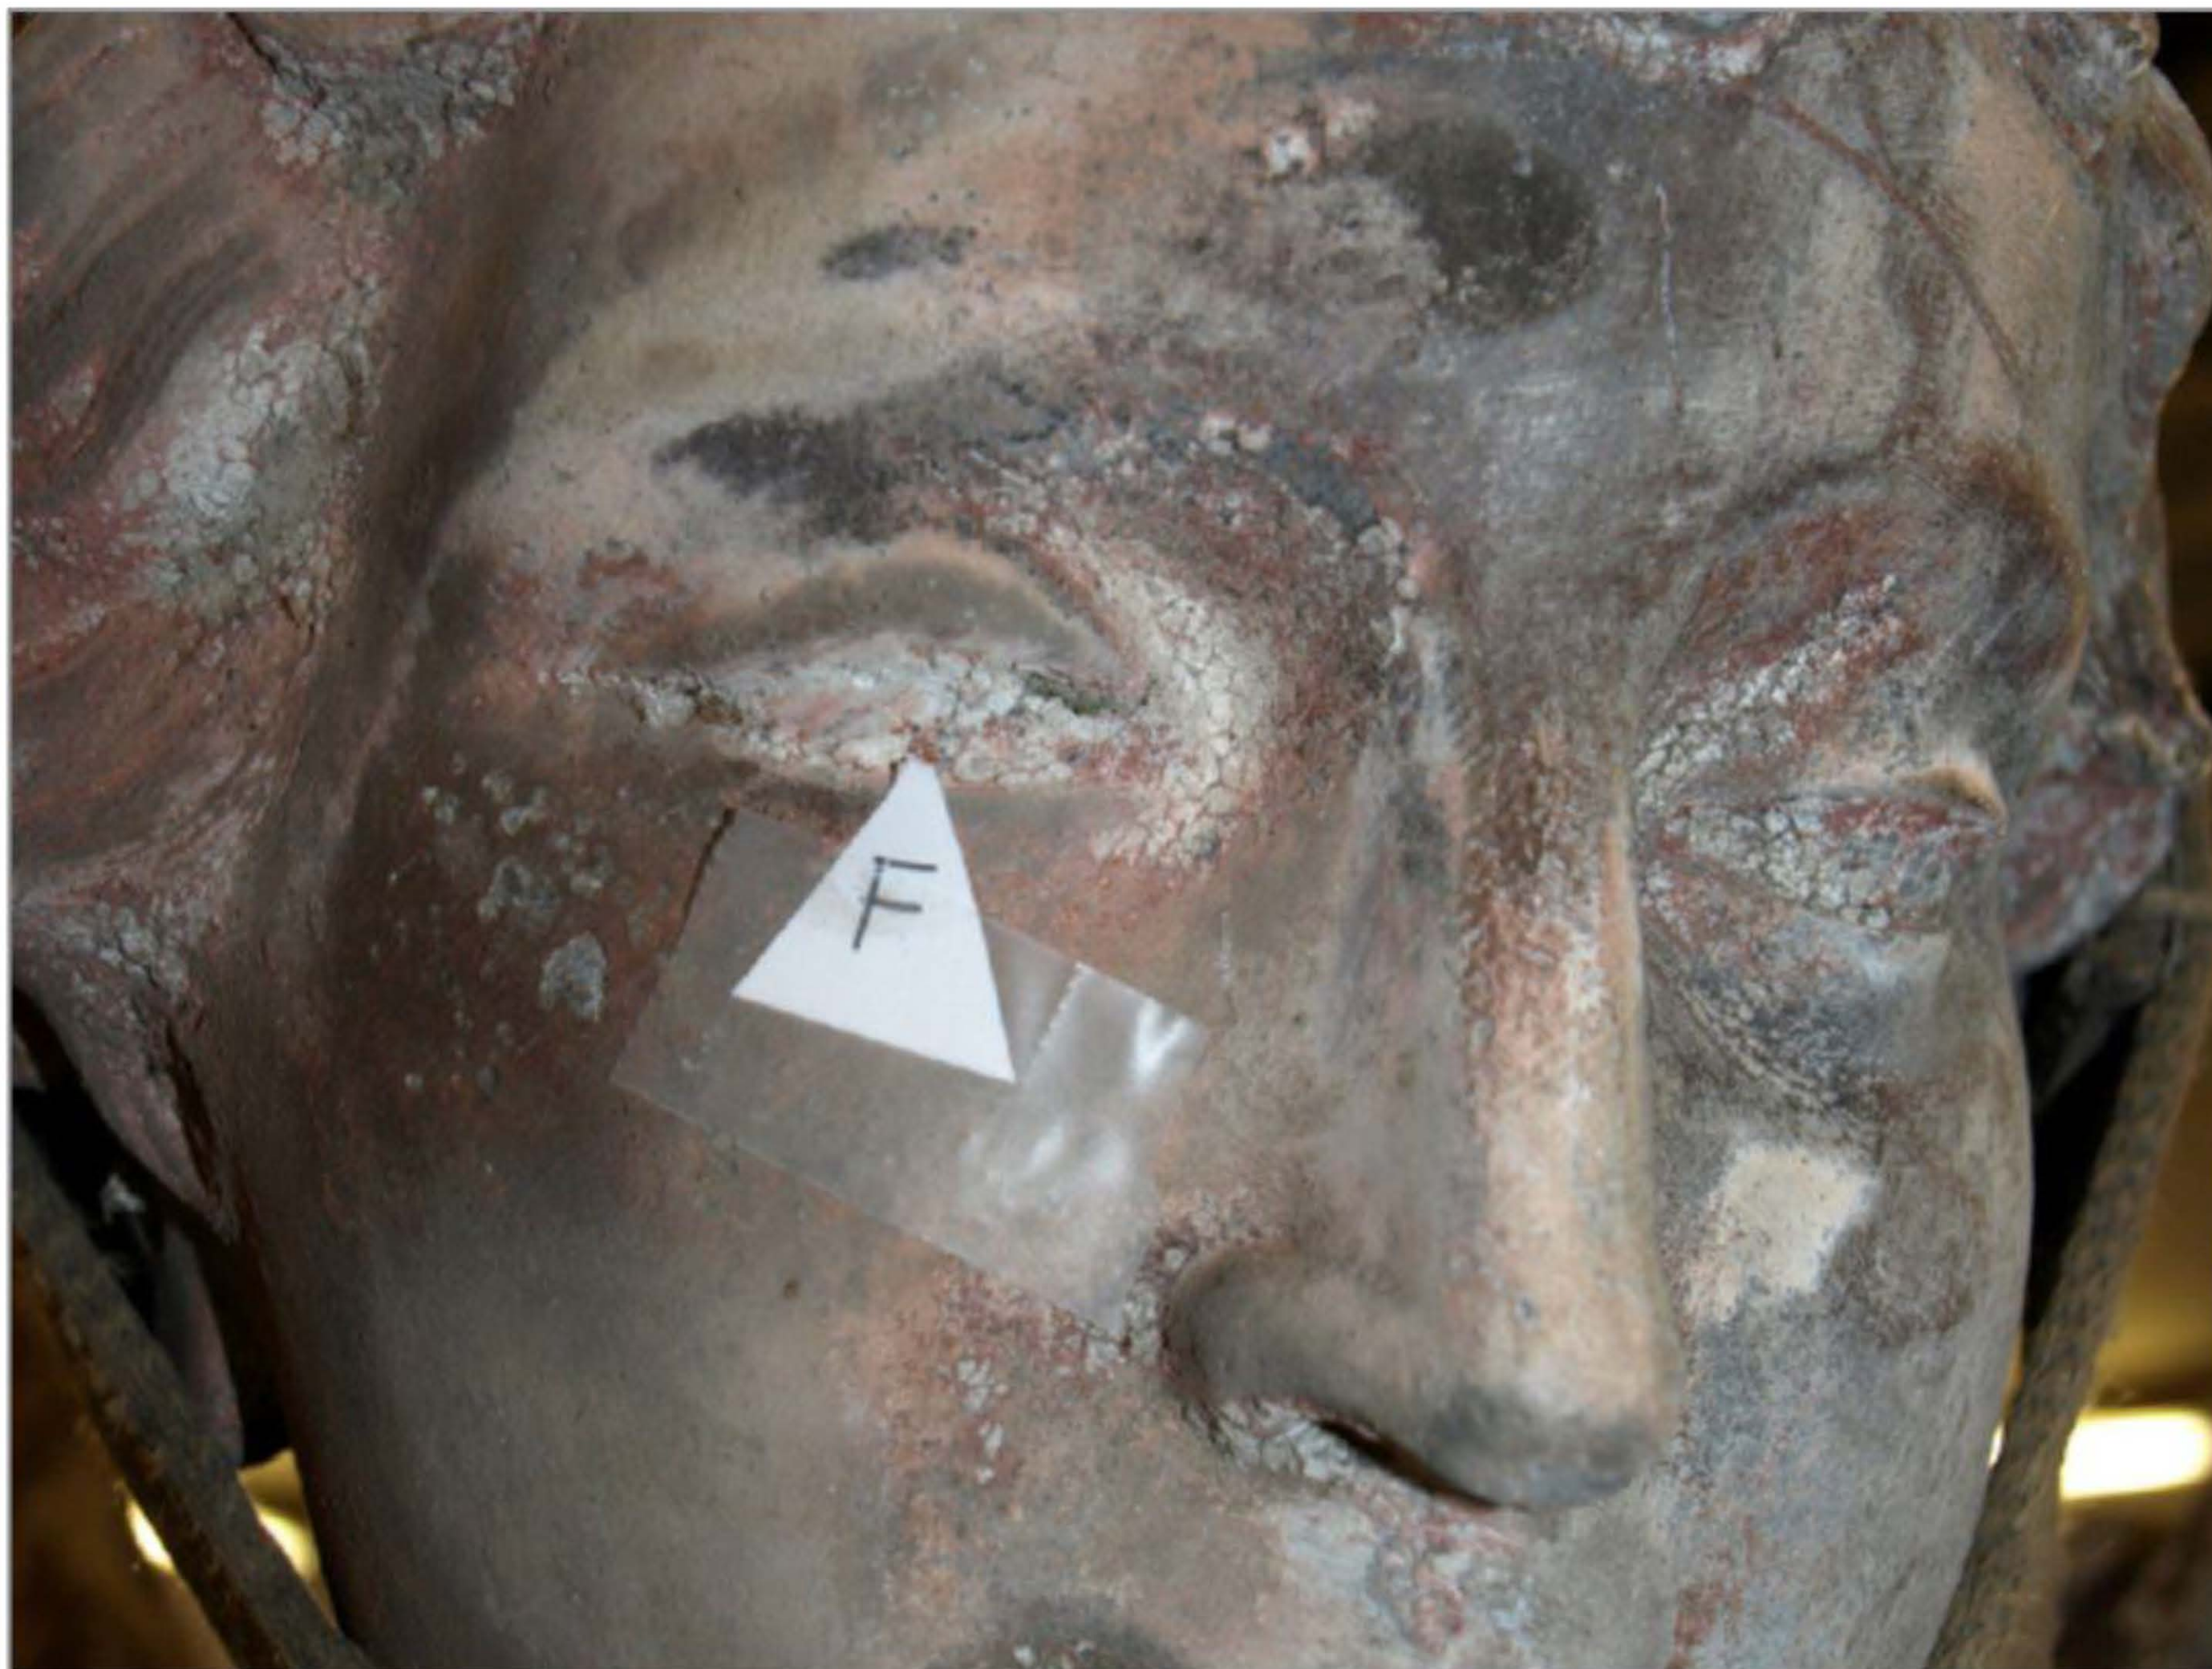
Traces of original paint can be seen in the recessed areas of this lead's surface. The red colouring is the primer coat. A careful note should be kept of the location of each sample taken for analysis and it is helpful to support written records with photographs like this.

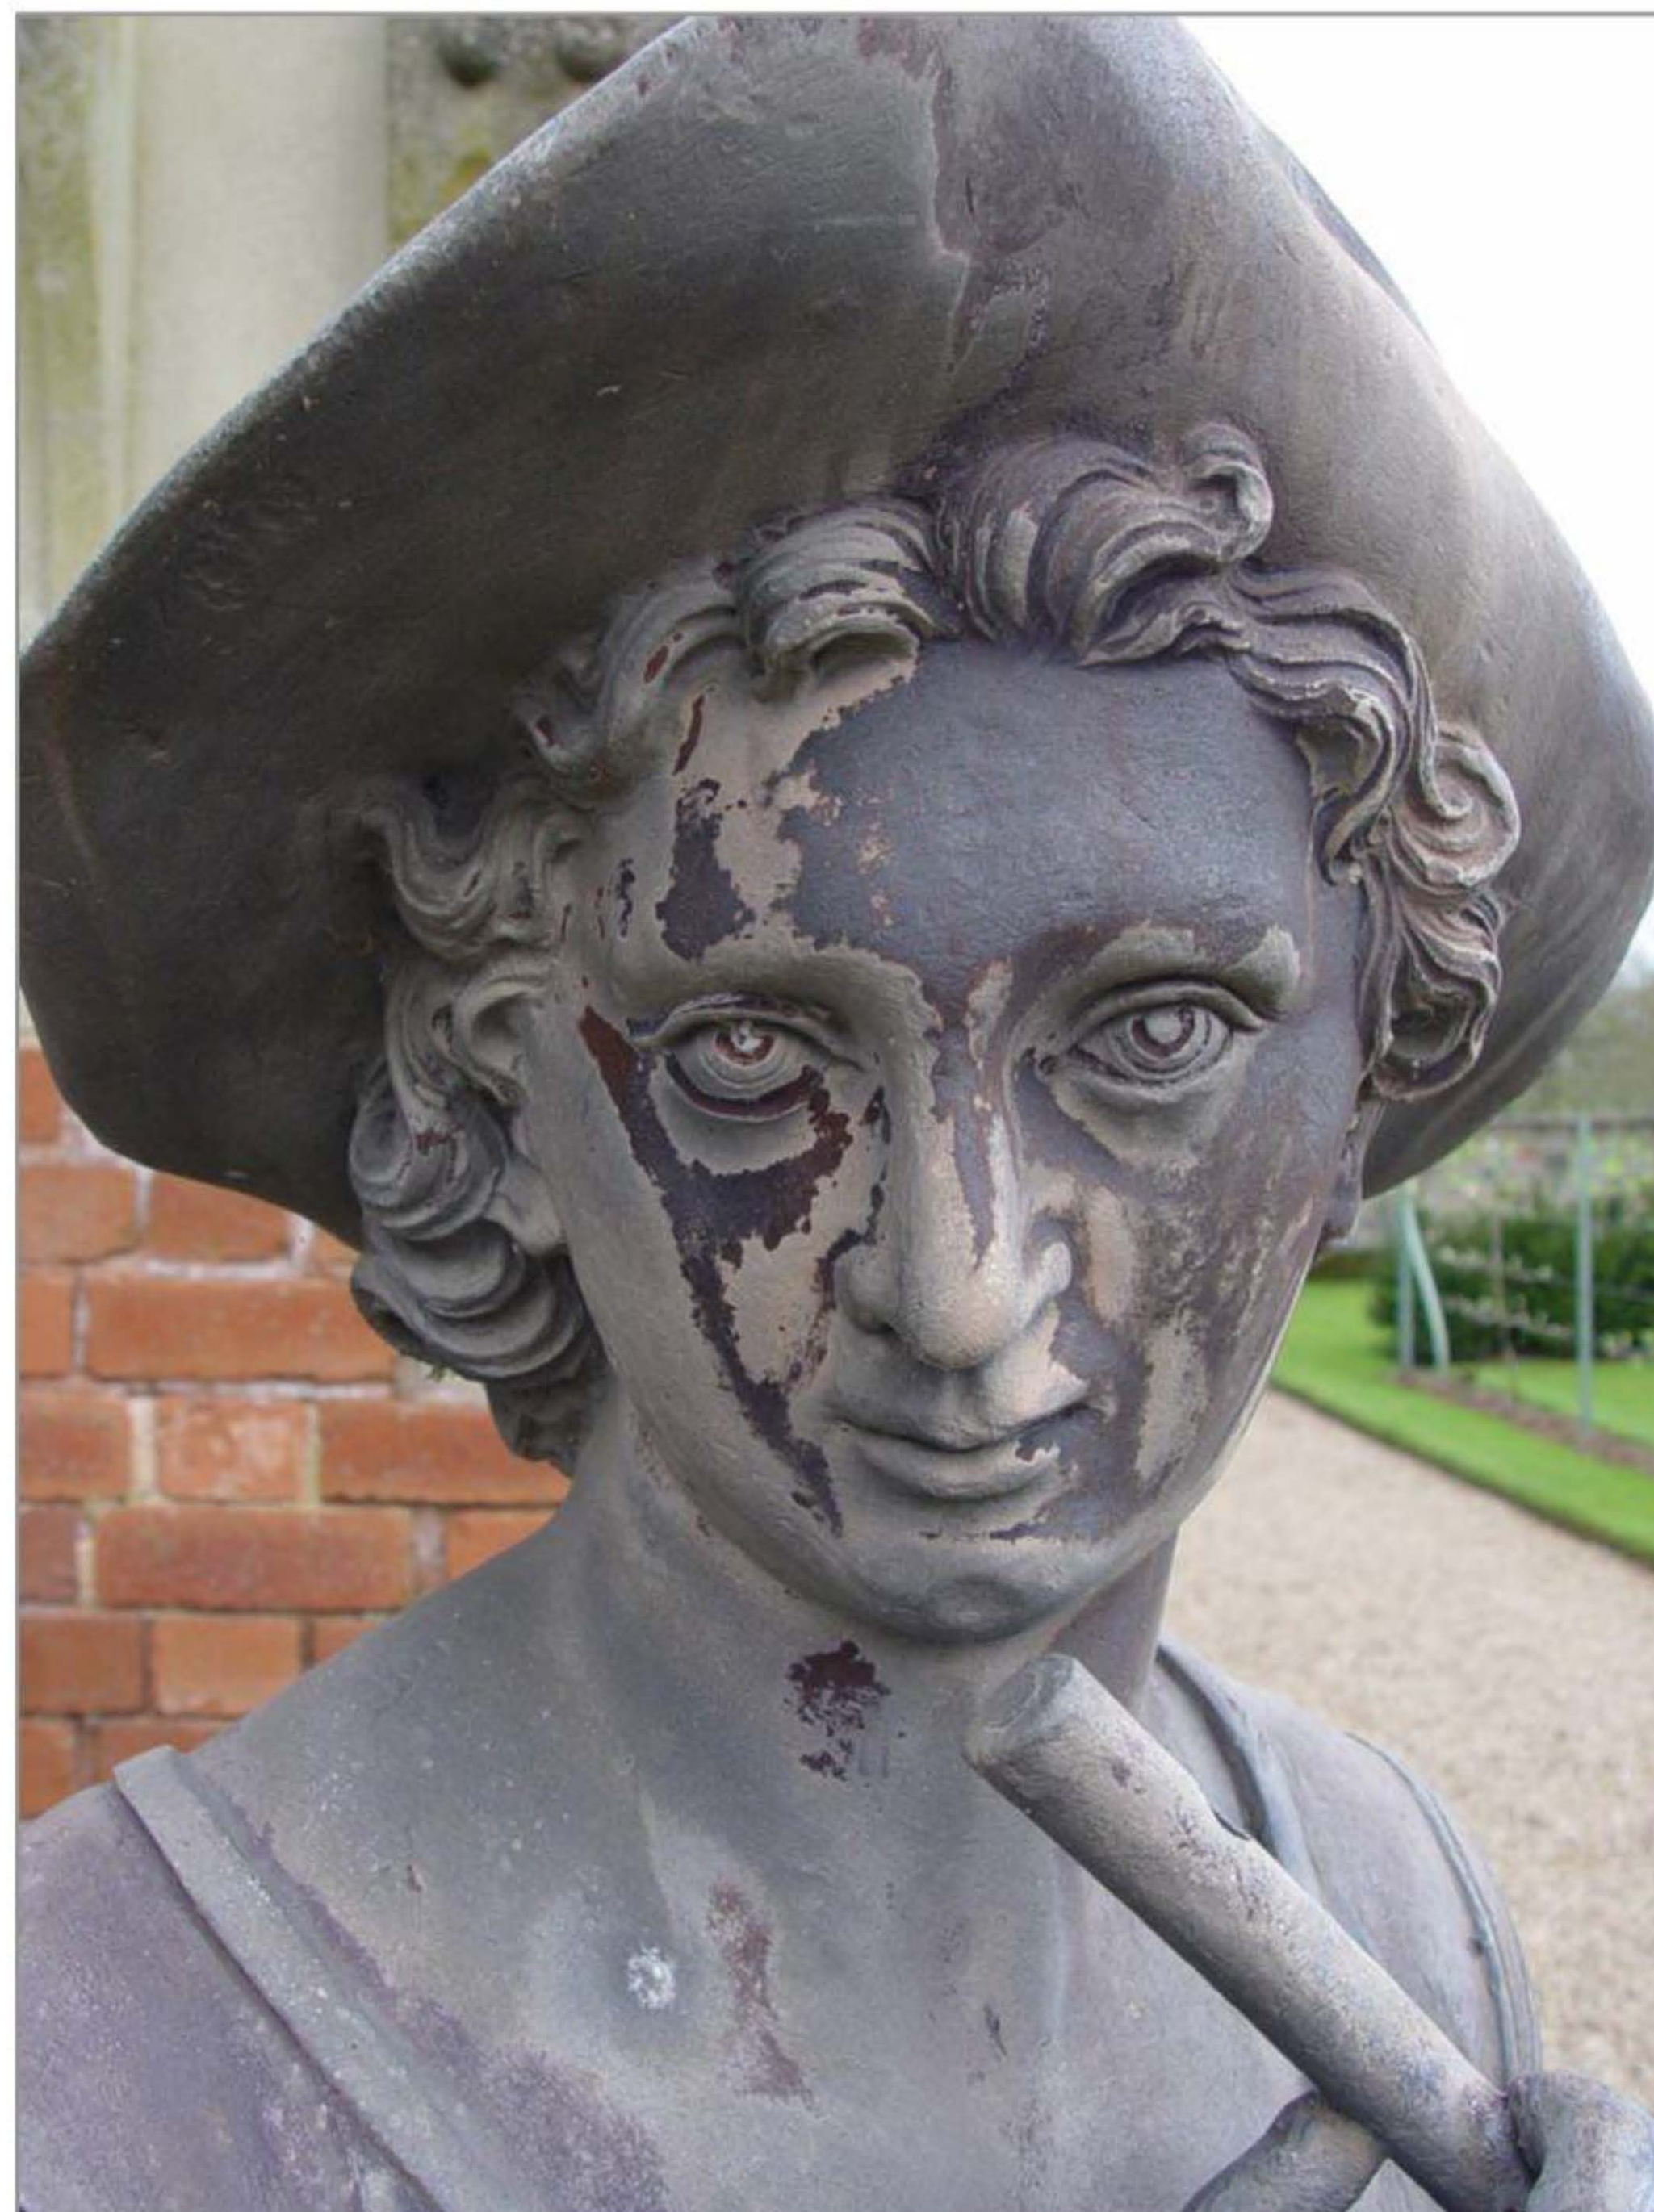
Lead dioxide formation on the Shepherd at Charlecote Park

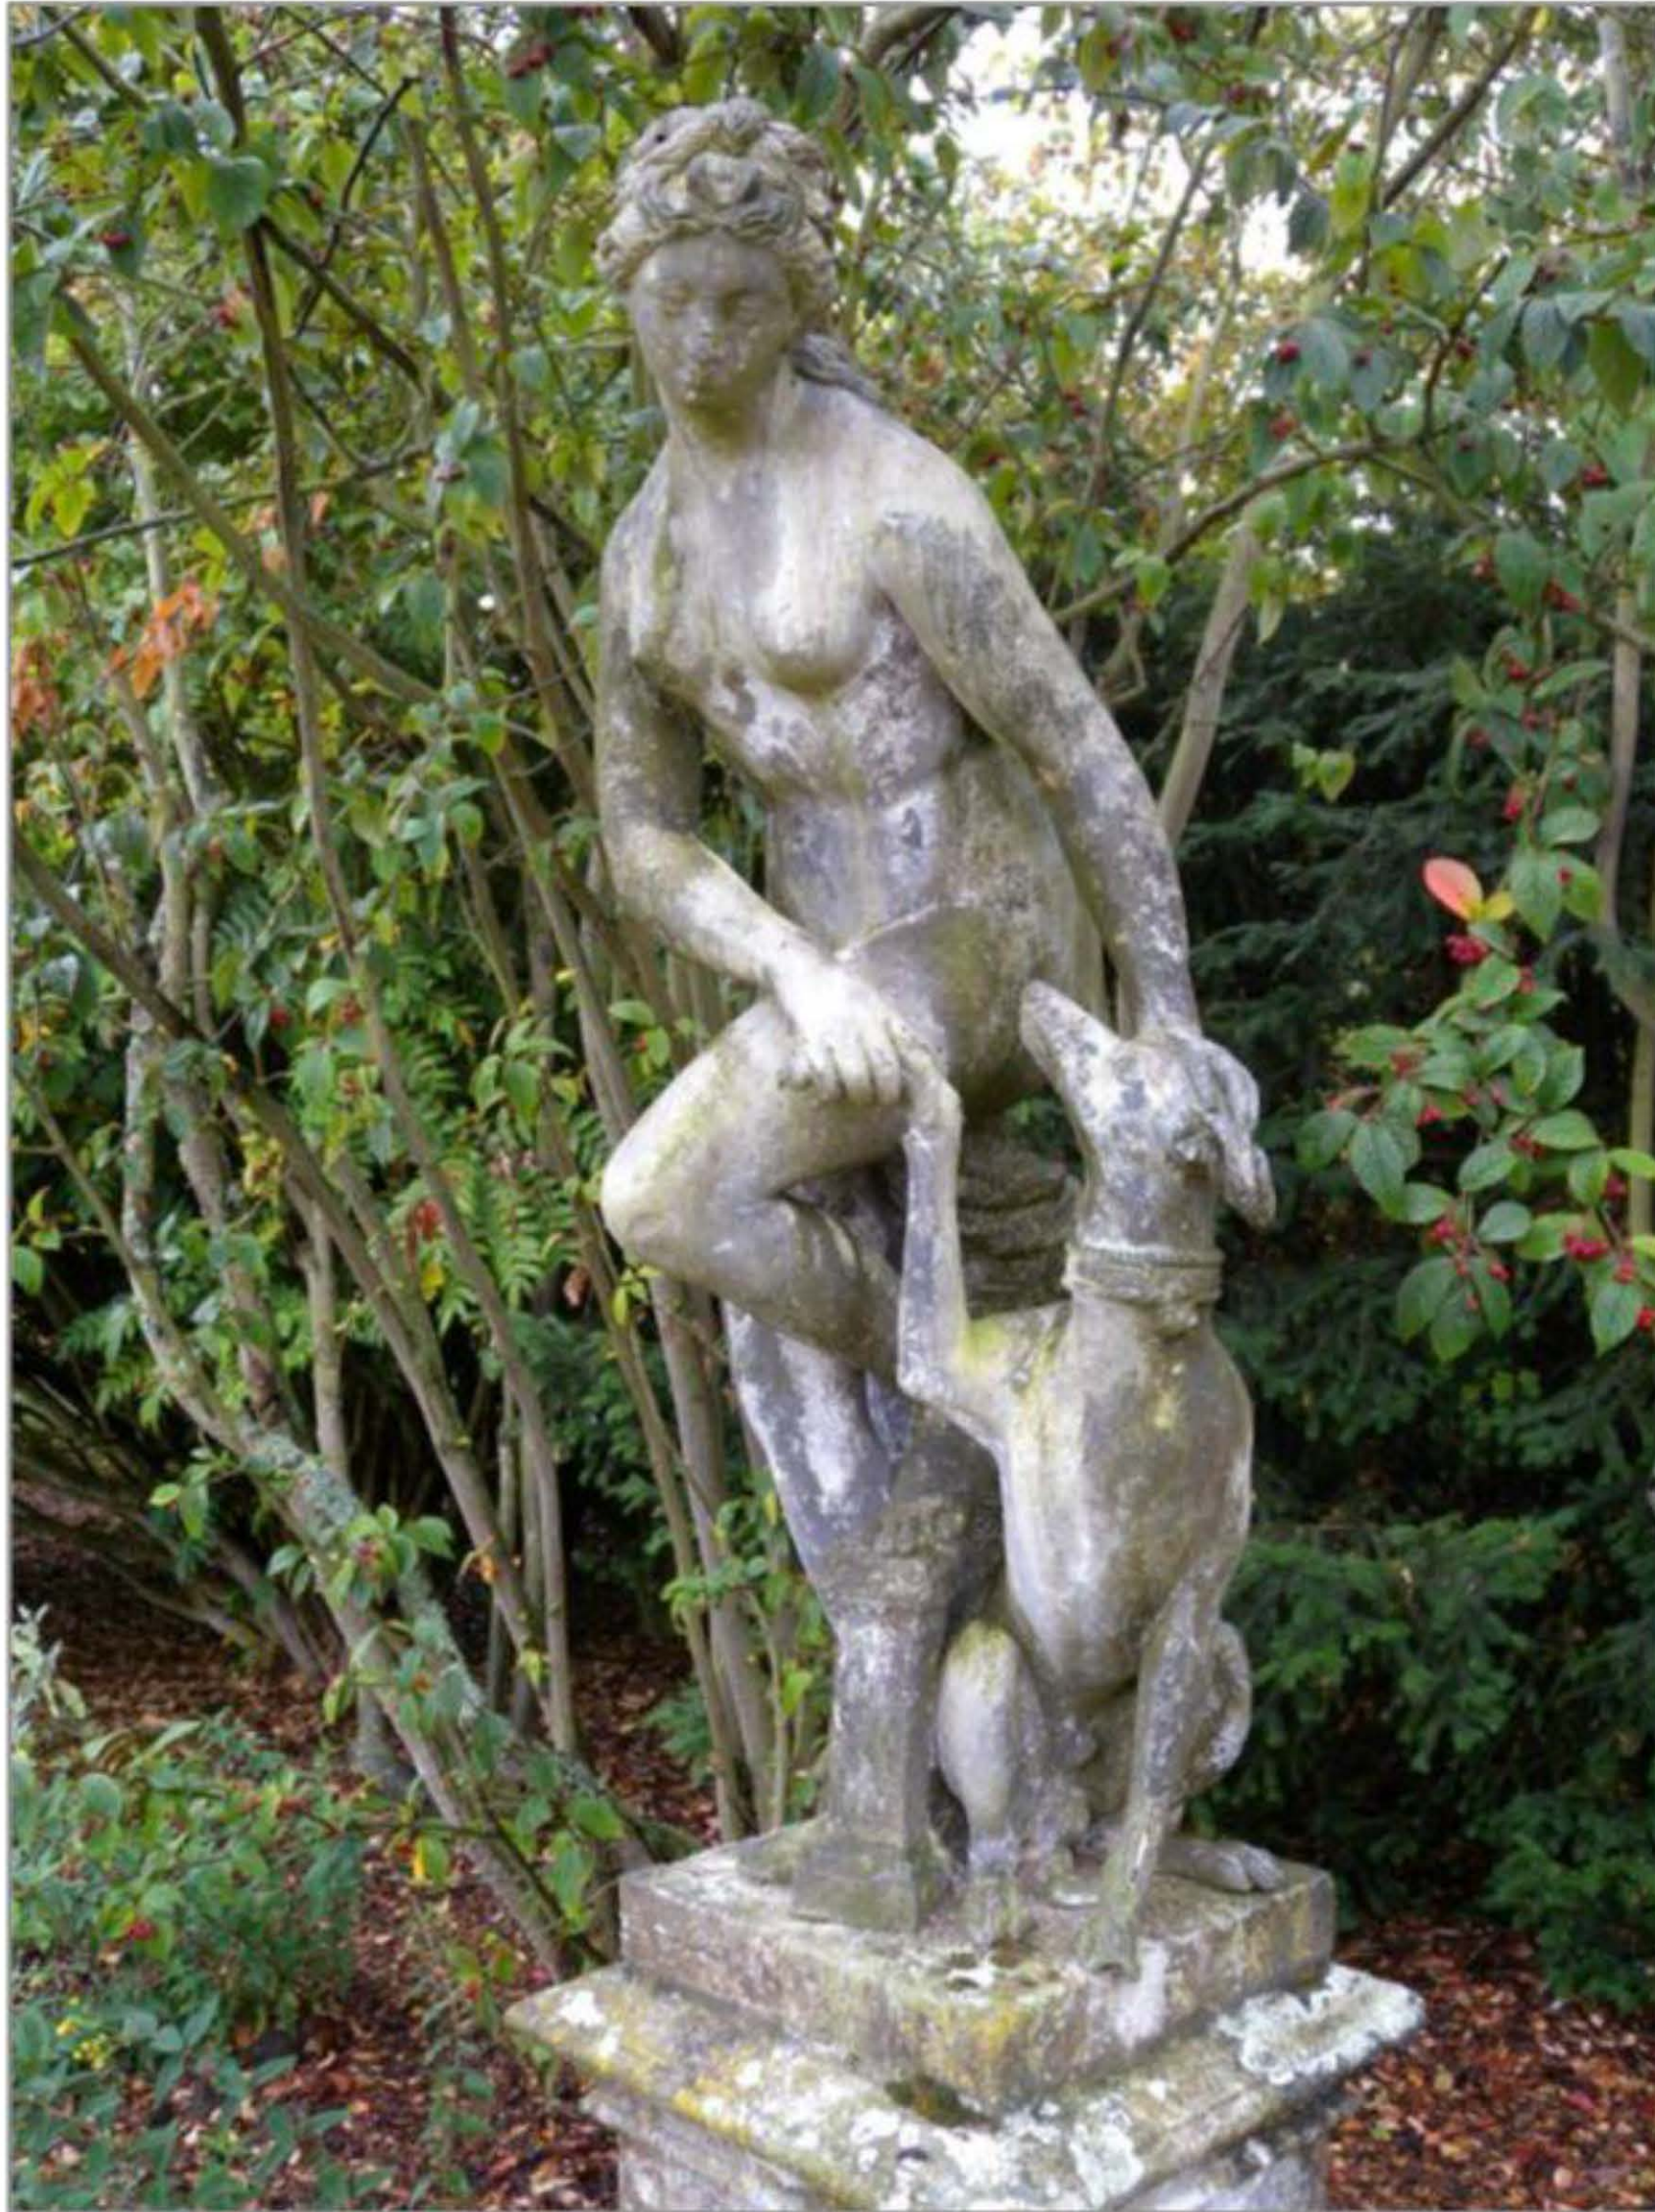
Before treatment

Example 1: Diana and Hound, Van Nost, returned to Wrest Park by English Heritage in 2012
