STRATFORD TOWN HALL

LISTED BUILDING CONSENT APPLICATION  
FOR CONSERVATION OF SHAKESPEARE STATUE

HERITAGE STATEMENT

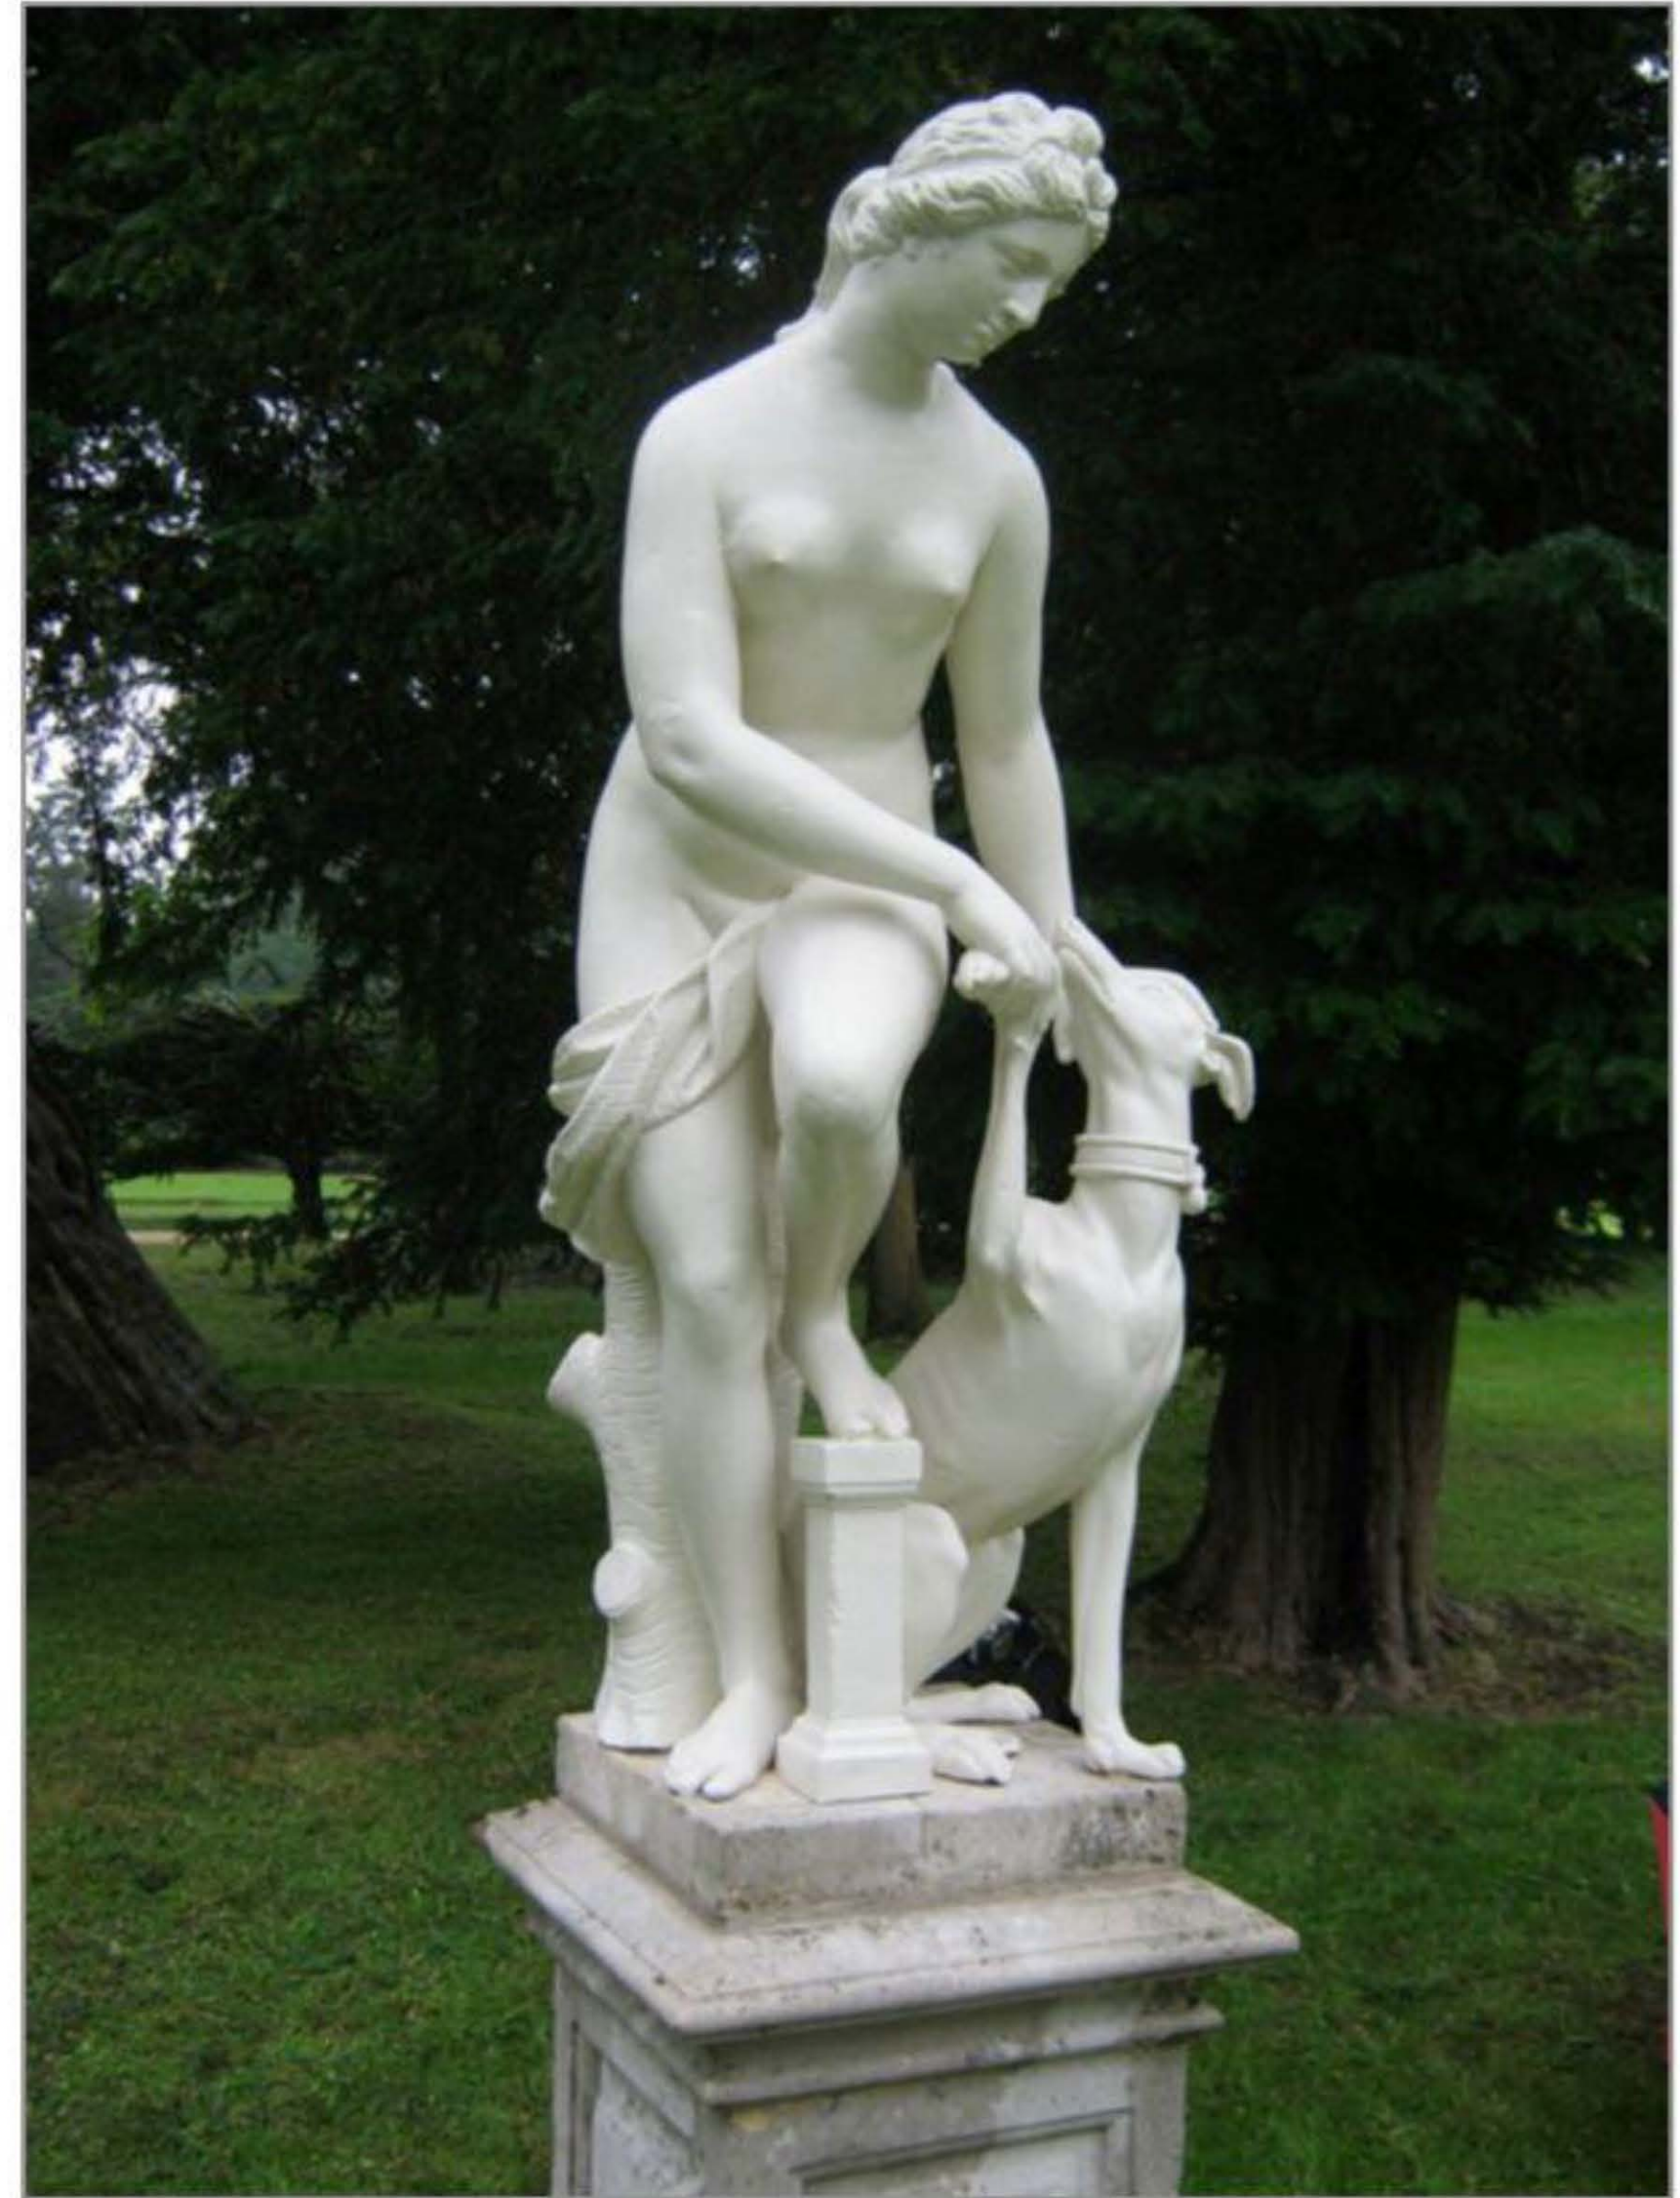
After restoration of the original surface

Paint samples were sent for analysis (see images overleaf), from which the following conclusions were drawn:

*In all the samples, the first paint found was a dark grey based on lead white and carbon black.*

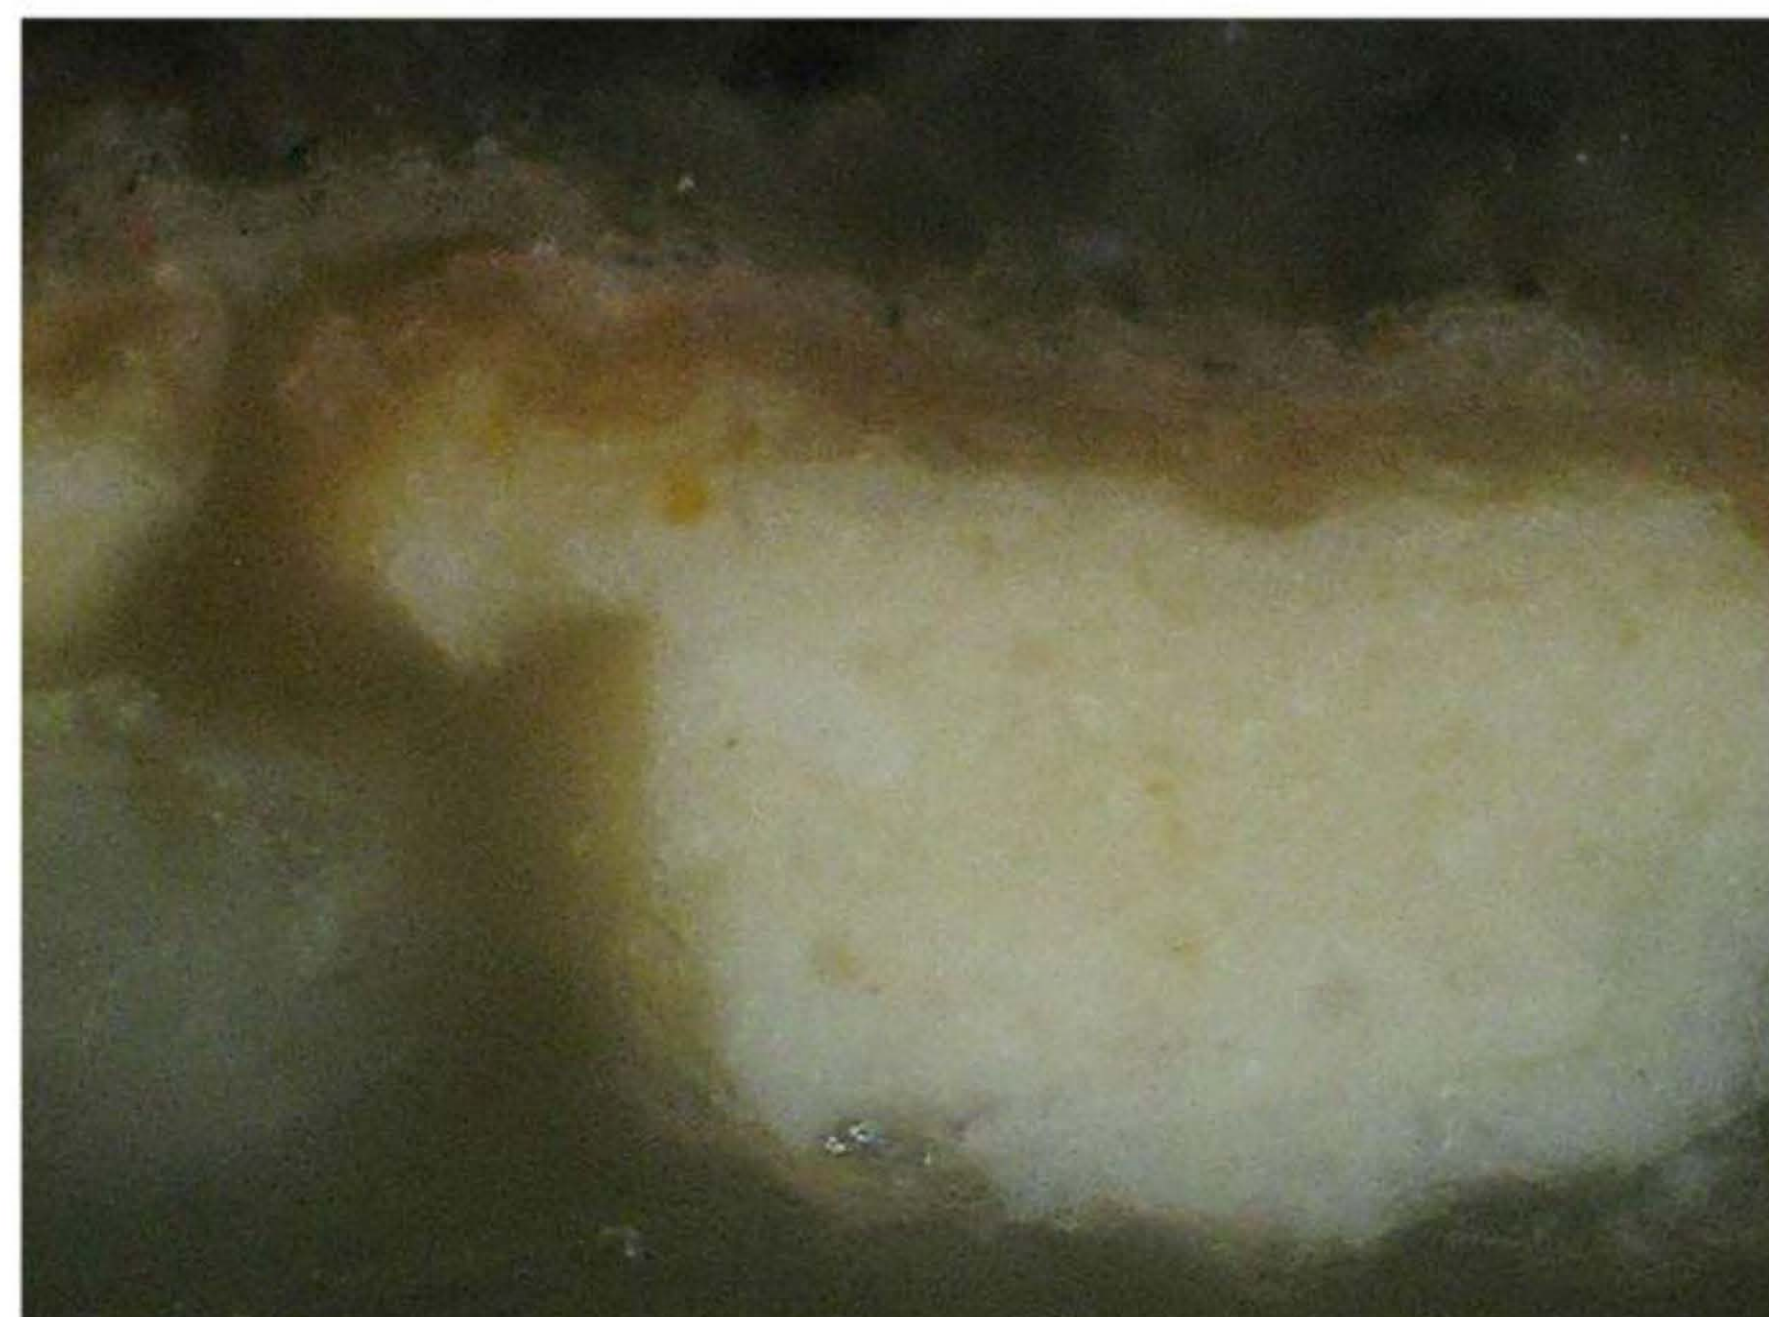
**SAMPLE 2**  
Fold of cloak

Showing paler and darker layers  
of sulphation over cracked  
remains of the original oil paint

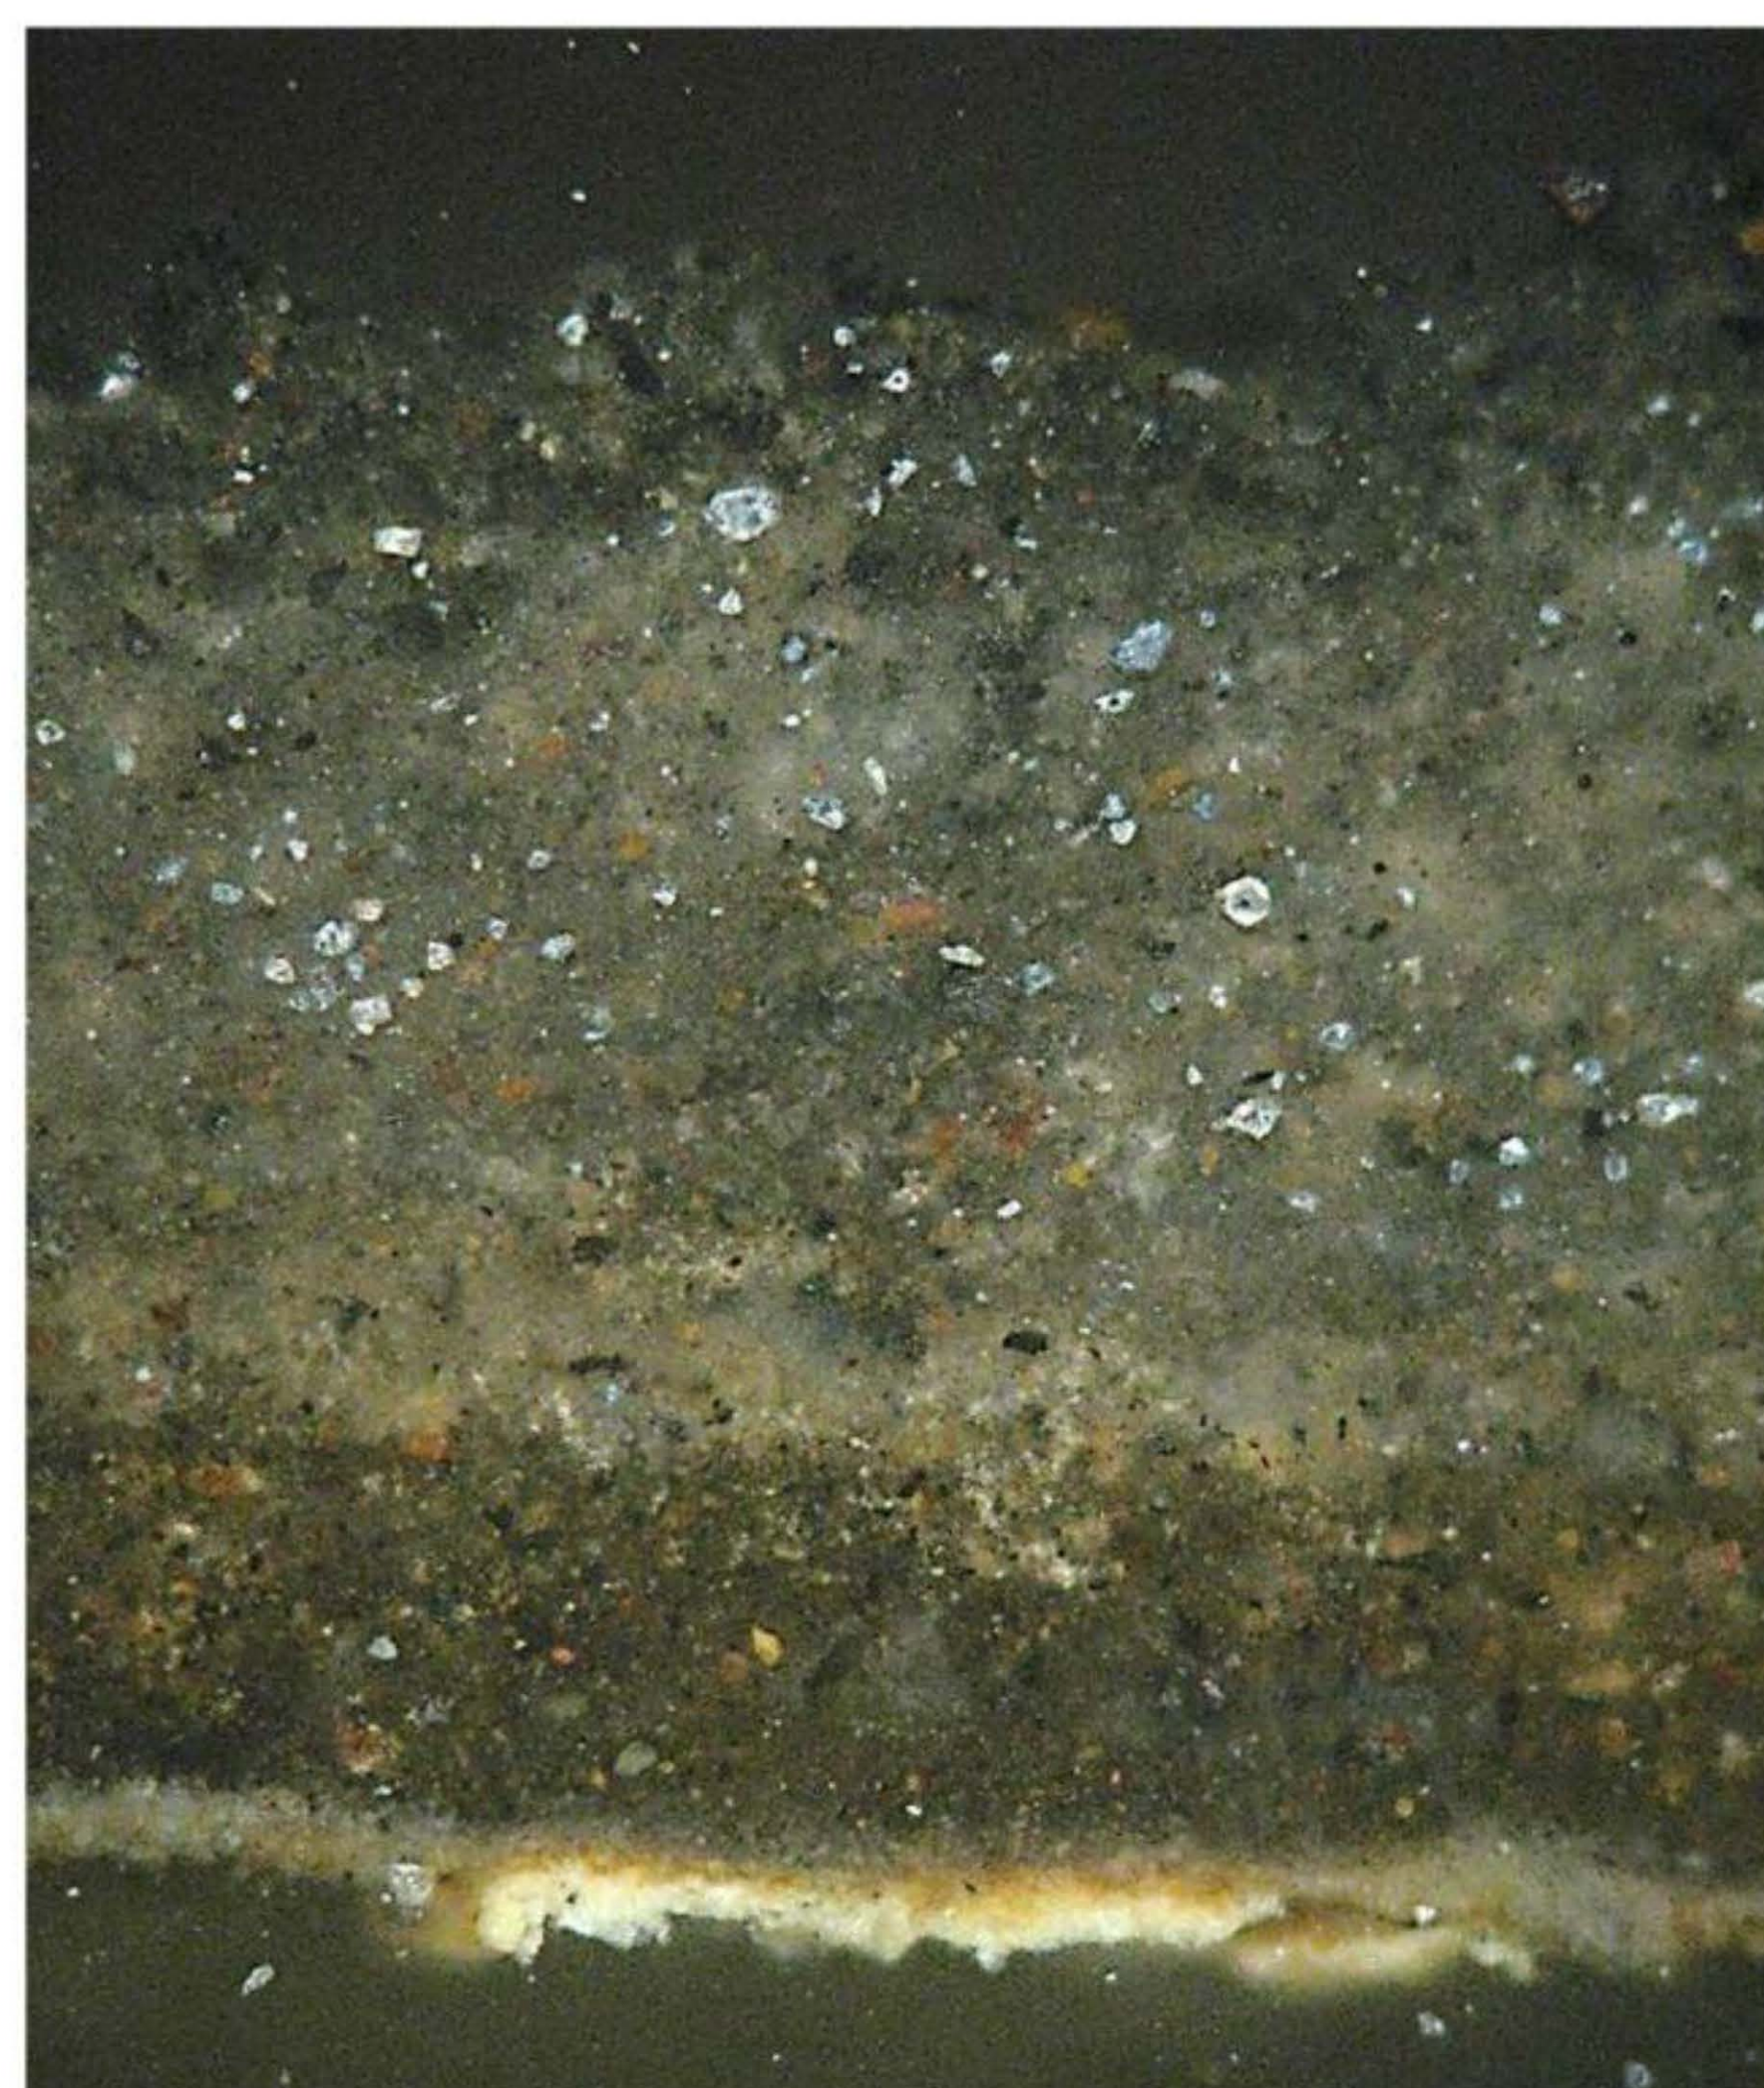
**SAMPLE 4**

Spine of book

Fragment (i)

Showing layers of oil paint sandwiched between layers of black sulphation
